Service done by: Tim Harisson/Benni Wijaya **Date:** 27/04/2022

RROA

DOT 11x9 Tool Service

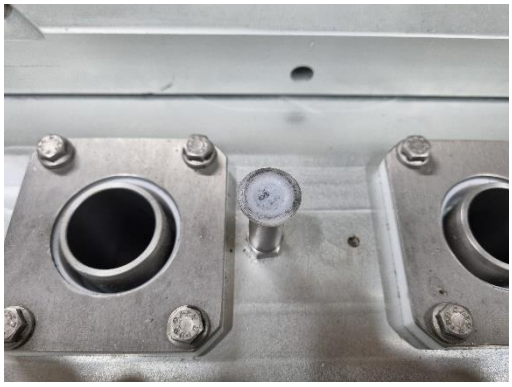
- 2x tray lifter stopper in the middle are worn, need to be replaced. No spare in the RROA store. **To be quoted.**

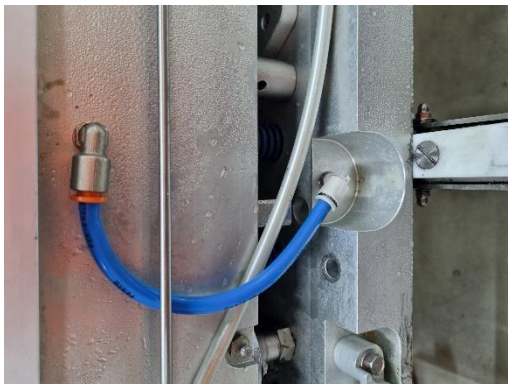
- Inspected cooling water hoses and fitting. Replaced 1x loose fitting

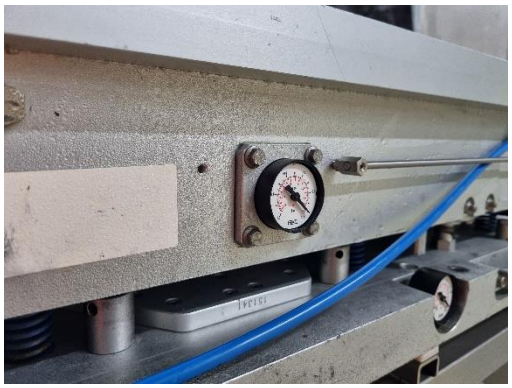
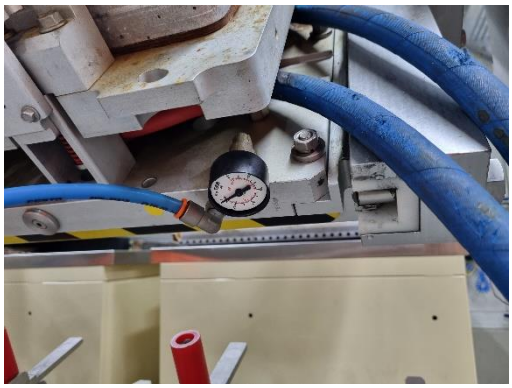
- Vacuum gauge have missing cover. **To be quoted**

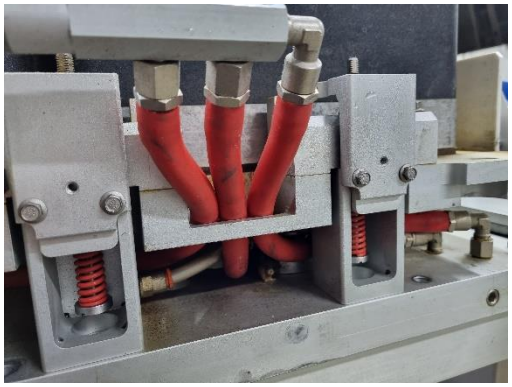
- Inspected red vacuum hoses. OK

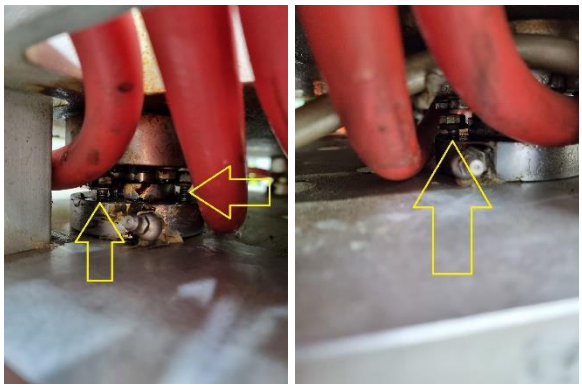
- Screws on top plate bush were loose. Tightened and lubricated.

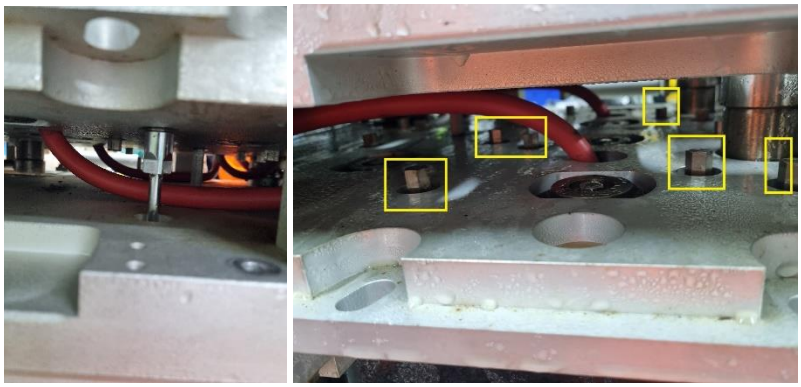
- Seal bar bolts were loose. Tightened all screws.

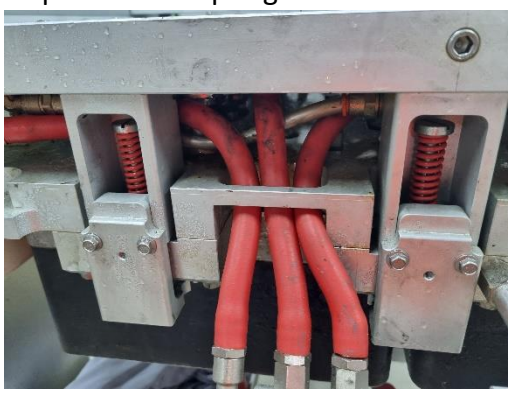
- Inspected Red Springs. OK

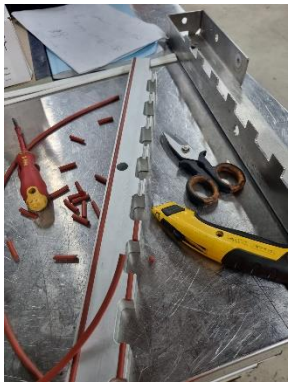
- Replaced O-cord for fixed clamps

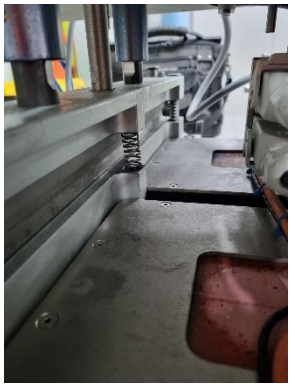
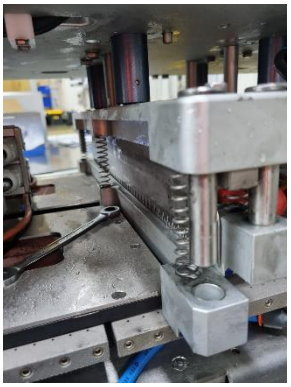
- Bottom cover guard spacer was broken and need to be welded.

- Replaced 2x damage springs on cutting group using customer spare
