UptimeEquip
Innovative Maintenance Support Program

Service done by: David van der Merwe **Date:** 08/12/2022

Huon Aquaculture

Mondini Trave 340

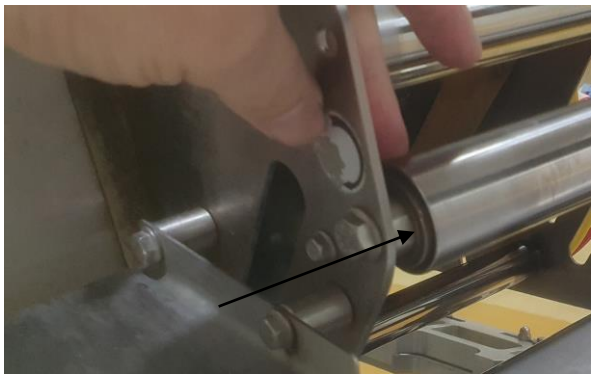
1. Cleaned all film path rollers.
2. Dancing bar in good working order.
3. Replaced missing Cir-clips on film path rollers. X4

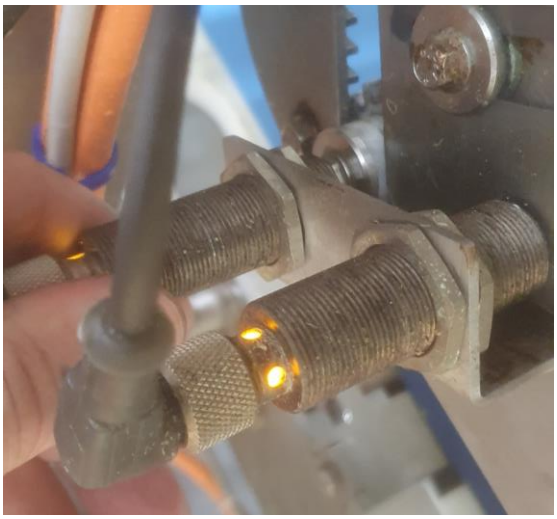
5. Inspected waste film drive all in good working order.
6. Did notice some ware on the Teflon coating on the film pre heater.
7. Tighten loose film end of reel sensor.

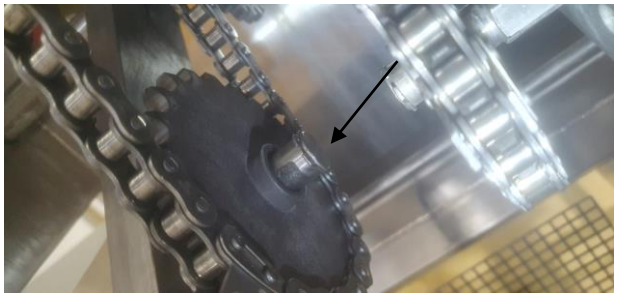
3. Saw some wear on the back idler sprocket pins.

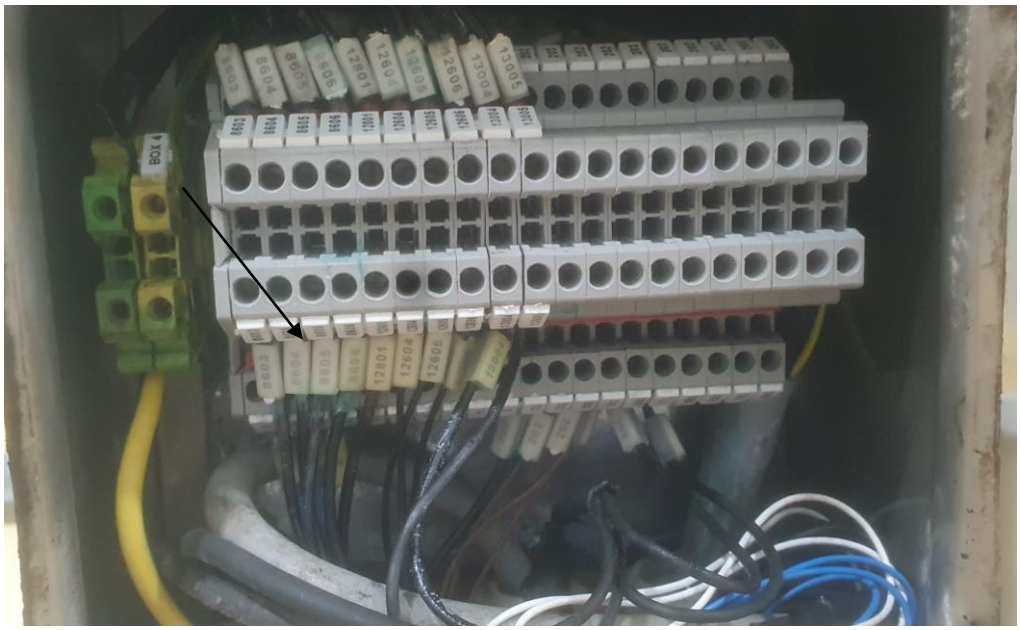
4. Inspected J/box and E-stops. Blowed out with air as there is a lot of moisture in them. Lot of corrosion.

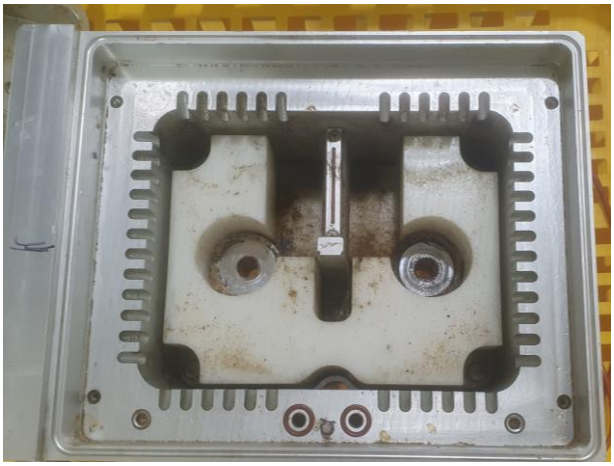
1. Stripped and cleaned bottom tool.

- Replaced foot plate shaft O-rings x4
- Replaced red O-cord on bottom tool.
- Stripped top tool lower bel and cleaned.

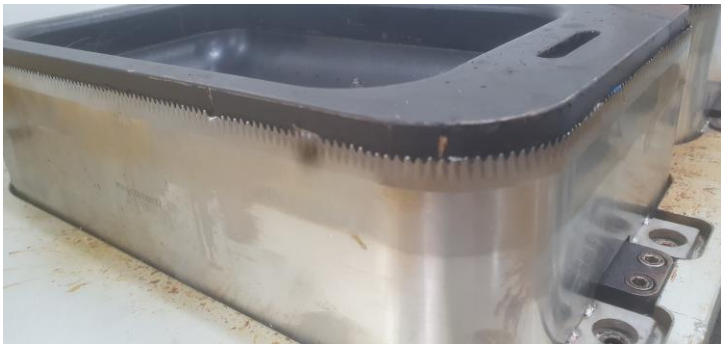
- Replaced both knifes had some damaged teeth

- Teflon coating on out feed side seal bar is badly worn. Need to be replaced asap. There was a lot of burn on seal.

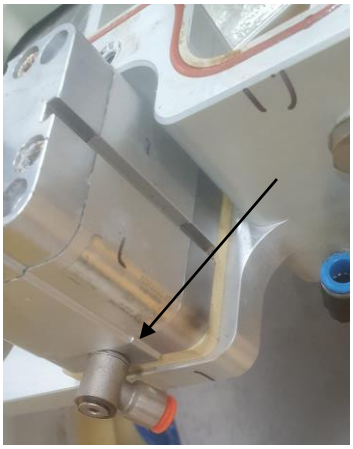
- Inspect case back plate vacuum holes. There is some ware on the case backs but recommend that they are only replaced when new seal bars are fitted.
- Replace bent air fitting.

- Tighten loose seal bar vacuum pipe banger connection.
- Replace all red O-cord.

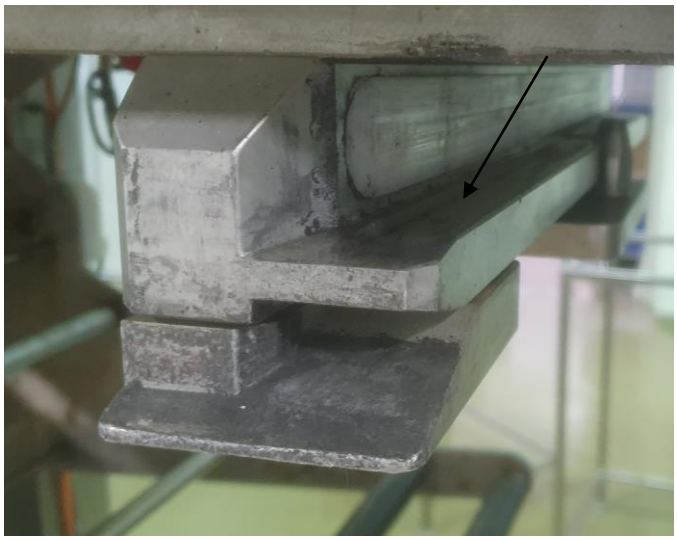
11. Fix bottom tool locking clamp in feed side. Was loose.
12. One of the nylon strips are missing top tool guide.

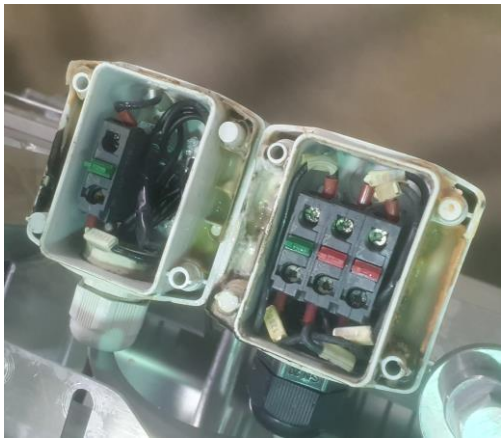
3. Inspect J/box, E-stops and control button boxes. Lot of water in them.

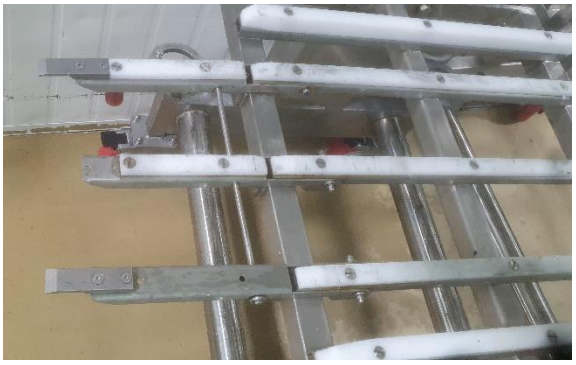
10. Inspect 6-pin plug and connections both tools.

Note that one of the tool trollies has a lot of missing parts on transfer slides
