GENERAL SERVICE REPORT

Subject: Line 2 – Supporting sealedAir/Hilton with the testing of the VST 211 film issue

Equipment Type:	Serial Number:	Customer Line # (if applicable):
Trave 590 XL	A18-A11895	Line 2

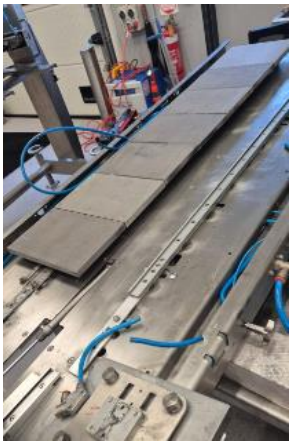
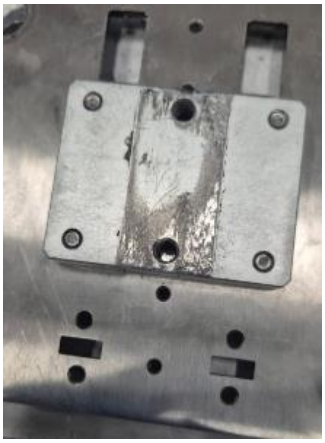
- Last day onsite for SealedAir at the Hilton site.
- Matteo Mapelli from SealedAir arrived in the morning with three new film reels, specifically organised for additional checks and confirmation of the film materials supplied.
- Upon arriving at the site, since the line 2 was only available from 11:00, I assisted the maintenance team in rebuilding the shuttle for line 1.
- Several damaged parts were identified, including a shuttle plate holding block, a worn plate hole thread, a broken plate pin and a broken PT100 probe. All were replaced using a spare shuttle from line 19 and a spare probe from the Modula.
