GENERAL SERVICE REPORT

Customer:	Lite and Easy	**Date:**	22 November 2024
Site Address:	54-72 Templar Road Erskine Park NSW	**Site Contact:**	Anthony Pisani
		Phone:	0438287226
Customer PO #:		**Internal Job #:**	4971

Subject: Tool rebuilds

Equipment Type:	Serial Number:	Customer Line # (if applicable):
Trave340 VG	A/16/A-11452	Line 1
Trave340 VG	A/16/A-11450	Line 2
Trave340 VG	A/16/A-11451	Line 3

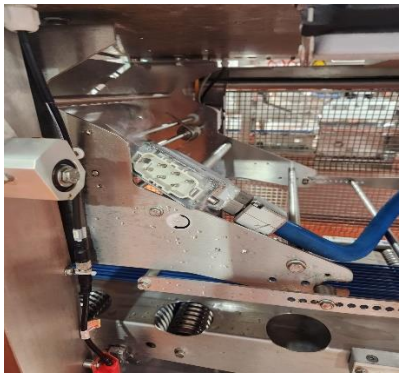
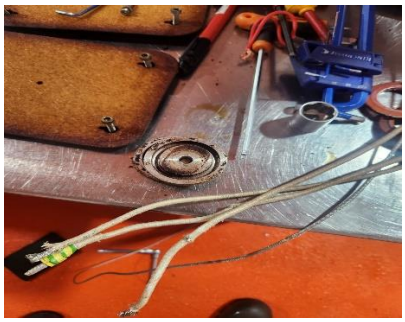
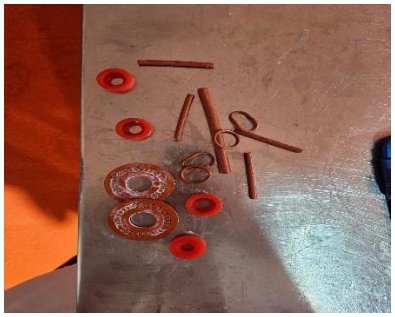
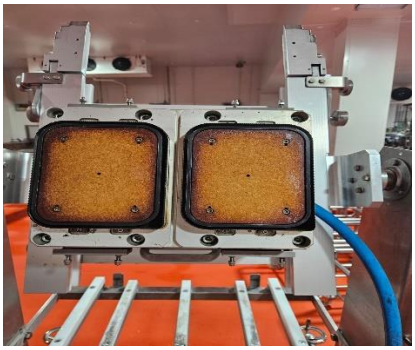
Dinner tool Line 1, 2 up.
This tool had a vacuum leak, smoke was coming from the Male heater plug. Tool was opened and found that a bolt was stripped, and a damage O ring was present on the pipe for resistance.

The bottom bush for the bottom tool is bent and should be replaced, non in stock. Will send a quote

- *Opened, cleaned and rebuild tool*
- *Replaced T seal*
- *Replaced 123 O rings*
- *Inspected bushes and O rings*
- *Inspected columns, should be replaced as one is bent. Non in stock*
- *Inspected Lower column should be replaced.*

- *Replaced 2 vacuum bellows and O rings*
- *Replaced 1 electrical bellows and O rings*
- *Replaced 4 springs*
- *Replaced blue electrical cable sheath, and O ring*
- *Replaced heater male pin*
- *Replaced Heater male pin holder*
- *Replaced 4 dampers*
- *Cleaned washers and installed 5 mil O rings, there was none under washer.*
- *Replaced all springs on top of element,*
- *Inspected disks*
- *Inspected upper columns*
- *Replaced red O cord*
- *Replaced PT 100*
- *Redid terminal connections*
- *Cleaned seal bars*
- *Inspected blades*
- *Retaped hole for pipe for resistance, bolt was stripped*
- *Inspected pipe for resistance and replaced O ring. O ring had damage*
- *Replaced O rings on lateral bushes*

- *Opened, cleaned and rebuild tool*
- *Replaced T seal*
- *Replaced 123 O rings*
- *Inspected bushes and O rings*
- *Inspected columns*
- *Inspected Lower column should be replaced.*
- *Replaced foot springs*
- *Replaced Damper O cord*
- *Replaced dampers*
- *Replaced vacuum gauge*

- *Replaced 2 vacuum bellows and O rings*
- *Replaced 1 electrical bellows and O rings*
- *Replaced 4 springs*
- *Replaced O ring on blue electrical cable sheath.*
- *Replaced heater male pin*
- *Replaced Heater male pin holder*
- *Replaced 4 dampers*
- *Cleaned washers and installed 5 mil O rings, there was none under washer.*
- *Replaced all springs on top of element, found 4 broken*
- *Inspected disks*
- *Inspected upper columns*
- *Replaced red O cord*
- *Replaced PT 100*
- *Redid terminal connections*
- *Cleaned seal bars*
- *Inspected blades*
- *Retaped hole for pipe for resistance, bolt was stripped*
- *Inspected pipe for resistance and replaced O ring. O ring had damage*
- *Replaced O rings on lateral bushes.*

- *Replaced foot springs*
- *Replaced Damper O cord*
- *Replaced dampers*
- *Replaced vacuum gauge*

RECOMMENDATIONS
Comments: Lower bushes should be replaced on the spare 2 up tool as they are bent. Both lifting colums should be replaced. Will send through a quote.
