GENERAL SERVICE REPORT

Customer:	RROA Coles	**Date:**	30/1/24 31/1/24
Site Address:		**Site Contact:**	Allen Vella
		Phone:	
Customer PO #:		**Internal Job #:**	4341

Subject: 11x9 VSP Shuttle

Equipment Type:	Serial Number:	Customer Line # (if applicable):
Trave 590	A17A-11614	Line 4

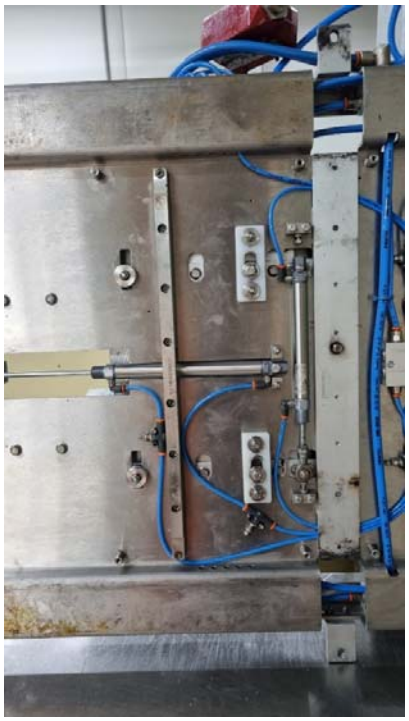
30/1/24
Arrived onsite for service on platformer tools but was asked to look at 11x9 skin shuttle
Removed shuttle from rack and moved to workshop
Speaking with customer shuttle had a problem with cutting on the first blade, film creasing on back corner of the first plate.
Set up pneumatics system and tested all shuttle functions all cylinder are working nothing sluggish
Tested cut functions all fine
Removed bottom shuttle for inspection

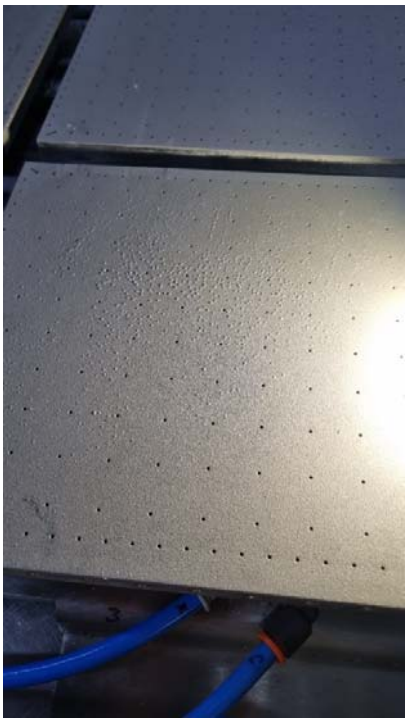
Inspected bottom plates and found the plasma coating is lifting and not letting film heat-up correctly due to film not sitting flat during film cycle

we need to order spare plates to keep production running and the original ones need to be sent away for recoating
Cleaned plates and reassembled shuttle

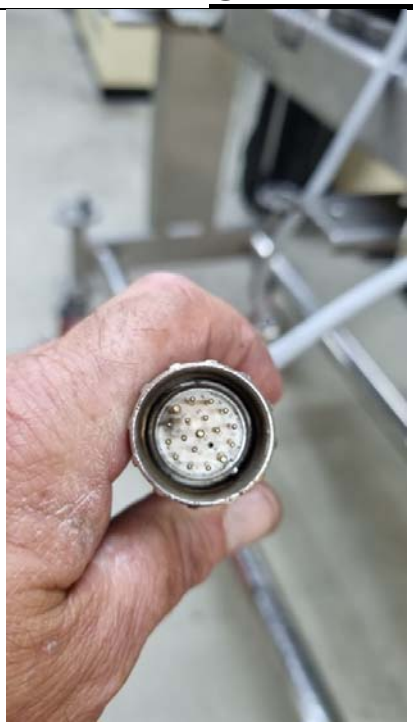
Inspection of heater plugs found the start of a hot joints recommend replacing plug I would say the heater is being unplugged before the shuttle in unlocked

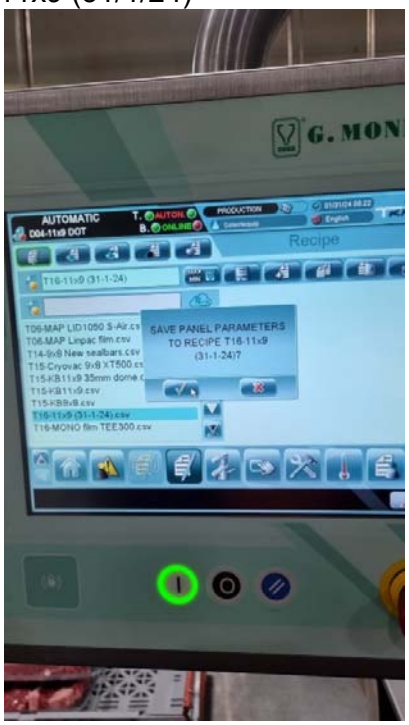
31/1/24
Arrived onsite to look over 11x9 production as they had issue running through the night
The root cause for the issue was not enough temp in the shuttle.
Fine tuned recipe and saved as 11x9 (31/1/24)
