GENERAL SERVICE REPORT

Customer:	Coles	**Date:**	05-07/09/2023
Site Address:	Coles	**Site Contact:**	Alan Villa
		Phone:	0438325453
Customer PO #:		**Internal Job #:**	4074

Rebuild 9x8 top tool and start-up

Equipment Type:	Serial Number:	Customer Line # (if applicable):
Trave 590	9x8 DOT tool	Line 4

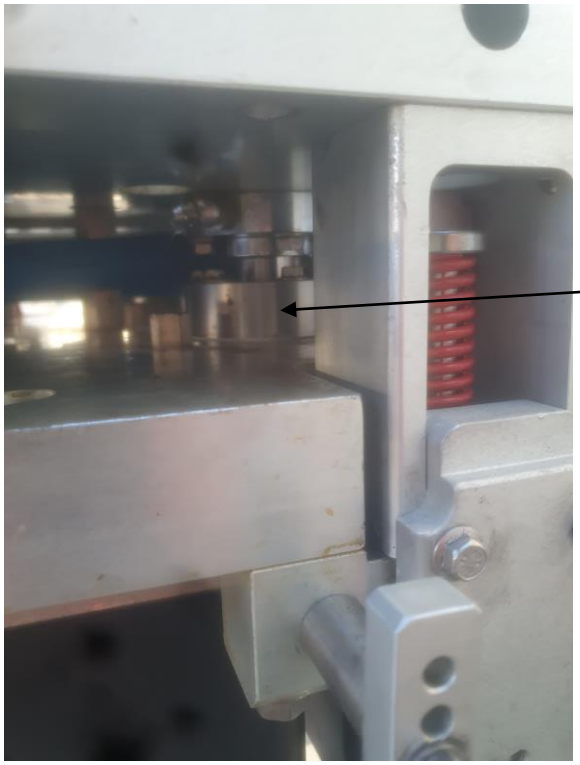
Replaced damaged tool up position striker.

- Replaced x2 vacuum gauges.
- Replaced x 8 red springs.
- Reassembled tool.
- Replaced all red hoses.
- Replaced on of the tool up position strikers was damaged.
