GENERAL SERVICE REPORT

Customer:	Huon Aquaculture	**Date:**	06,07,08/12/2022
Site Address:	7218 Bass Highway East SASSAFRAS Tasmania	**Site Contact:**	Anthony
		Phone:	0428776039
Customer PO #:		**Internal Job #:**	2056
Subject: Service and Film Trial

Equipment Type:	Serial Number:	Customer Line # (if applicable):
Trave 340	A/14/A-00911	Raw
Trave 340	A/14/A-00912	Skin Line

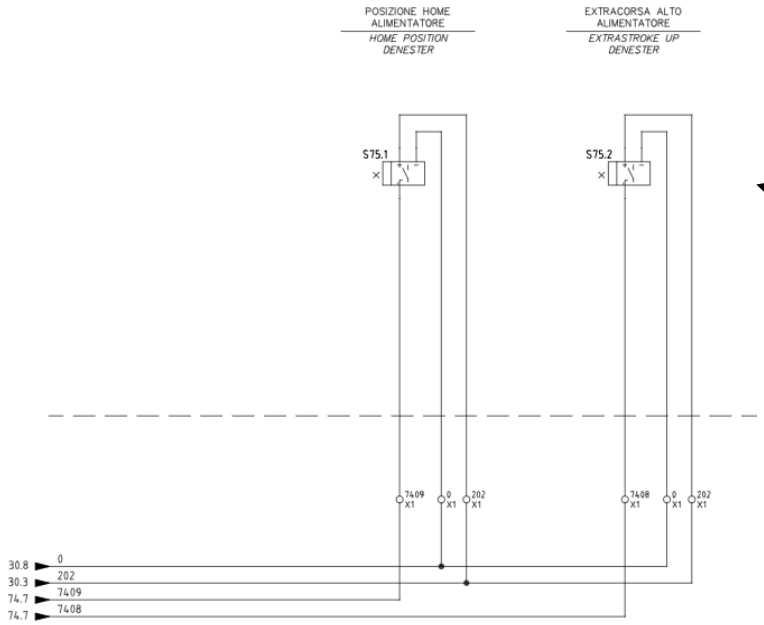
- Completed service on the raw line. Inspected chain line and fixed stuck chain tensioner. Found a lot of water in E-stop and control button box's
- Test denesting unit, found problem why unit will go in to axis fault after homing. The extra over stroke up reed switch has a falls signal on it and when testing on voltage there is 15VDC on the signal wire constantly when the reed switch is not made. This can be caused faulty reed switch or damaged cable to J/Box. With this reed switch disconnected I managed to home the system and start chain line and denester, but the electrical cylinder is very stiff and jerky when moving causing system move irregular and effecting movement and stopping. The electrical cylinder needs to be stripped and cleaned and if it can be repaired it will have to be replaced.

Extra over stroke reed switch and signal cable to J/box must be replaced
