GENERAL SERVICE REPORT

Subject: Forming and Extractor issue

Equipment Type:	Serial Number:	Customer Line # (if applicable):
Platformer	11614

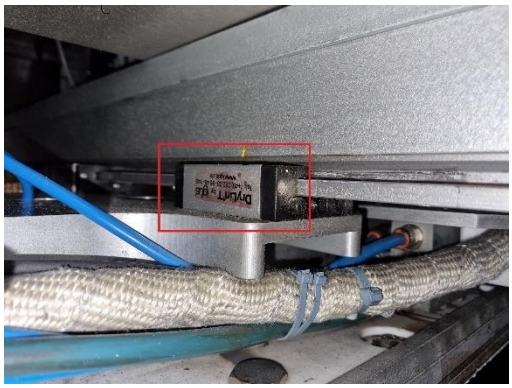
- Test run machine and noticed issue on forming. The 1st and last tray were fail to form on the short edges. Tried different ways of forming settings without any success.
- Thanks to Tom Darwen's help, he picked up faulty linier bearings on Load PeP. Bearings have big play about 10mm. This play will cause film to not line up/has an angle when loaded into low tool.

- Checked and found 2x spare bearing in store. Since there are 4x needed and only 2x in spare, we decided to replace 2x in diagonal. Load PeP play was improving a lot after the repair.
- Test run machine but this time only 1st tray is fail to form but in different side of short edge.
- Observed further and noticed fail was always happening on Top Tool#1.
- Set machine to run different Top Tool configuration using 2&4 plates instead of 1&3.
- Test run machine, forming was good on both plates in every cycle.
- To ensure proper unload PeP after lip moulding cycle, we decreased % speed of lower tool opening after lip moulding to 10%.
- Monitoring production run for about 15mins with maintenance team, forming and tray unload was working well
- Saved these new setting under new recipe named "Plantic MAP 2+4 Tom"
