VOLVO PENTA SPEED RELAY

A Guide to Testing & Repair

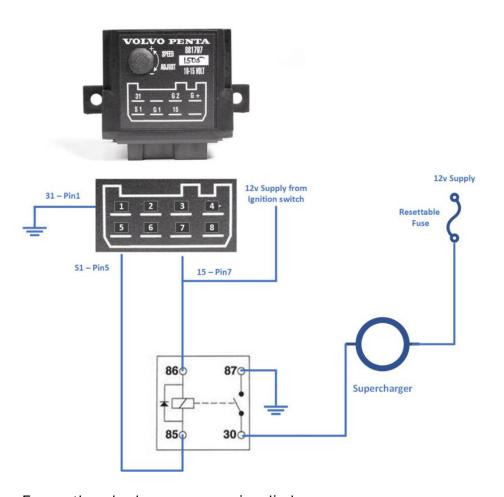
Consider fitting a relay in between the supercharger and the Volvo speed relay. This will protect the speed relay from damage when the clutch coil fails.

Ensure the relay has a suppression diode.

The diode should be installed in the relay with the stripe on the diode body facing towards terminal 86 (reverse biased) and it is important that +12V is connected this terminal.

Diodes are usually installed with the band (Cathode/Negative) of the diode facing to terminal 86 (if positive reverse biased) & is critical that 12v be connected here and not to 85 to prevent diode damage and relay box damage.

Note: Some relays have the diode is reversed - please check before installing.

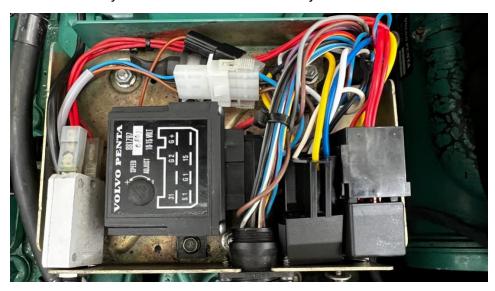
Protection relay installed next to starter relay
