VOLVO PENTA SPEED RELAY

A Guide to Testing & Repair

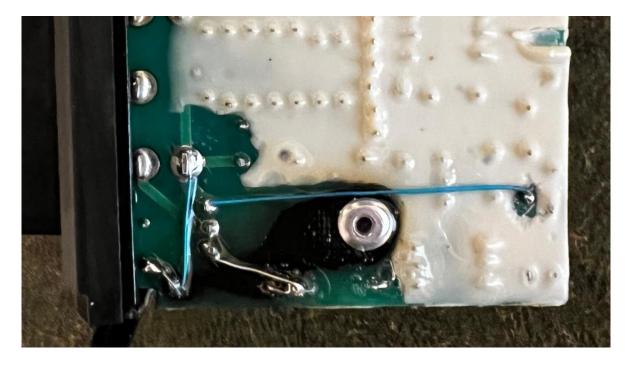
Example of a damaged board

Whilst the board has suffered from heat damage which has also damaged some of the tracks and the pads it is still repairable, although the repair will be obvious.

The damage destroyed about 5 tracks and 2 through holes. The heat also damaged 2 other components on the board.

The board has been repaired and a new transistor has been riveted in.

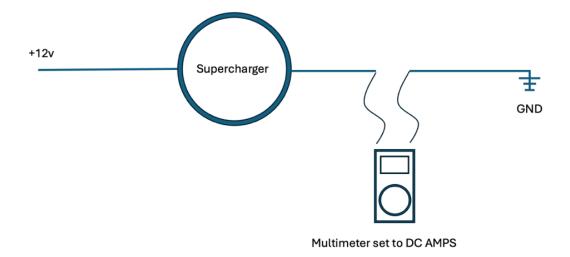
Measure the current between pin 1 and pin 5 on the connector. The reading should be circa 3.75 Amps. The clutch will make an audible clunk as the measurement is read.

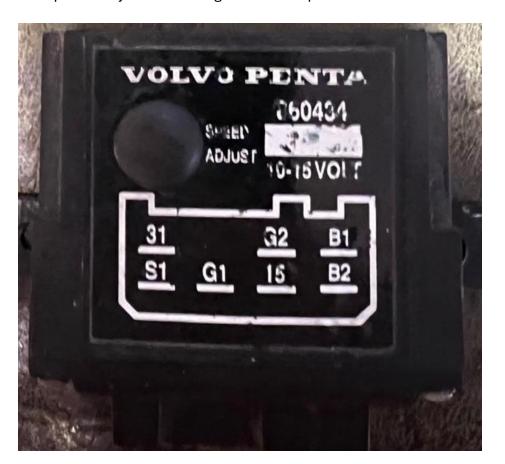
With the connecter re connected and the engine running, connect an oscilloscope to the speed relay: P6 / G1 – the expected signal is shown below.
