Latent Fragility

Hidden Structural Flaws, Coupled Cascades, and Catastrophic Engineering Failures

CONTENTS

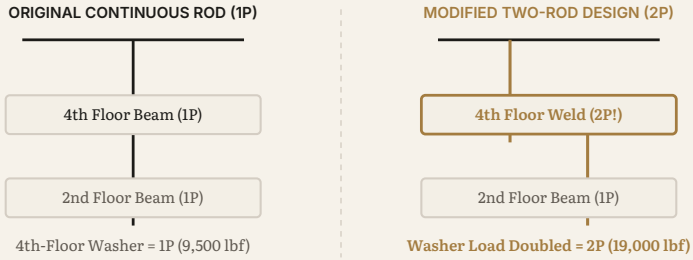
When steel fabricator Havens Steel reviewed the drawings in early 1979, shop detailers objected that 46-foot continuous threaded rods were impractical to manufacture, ship, and install. Ironworkers would have had to spin hexagonal nuts up twenty feet of exposed steel threads to reach the fourth-floor beam, risking thread damage during erection. Havens proposed a seemingly simple substitution on `Shop Drawing 30`: replace each single 46-foot continuous rod with two shorter offset rods. An upper rod would run from the ceiling truss down to the fourth-floor box beam. A second lower rod—offset four inches inward along the same box beam—would hang from the bottom flange of the fourth-floor box beam down to the second-floor walkway. Gillum-Colaco stamped the shop drawing approved without recalculating the connection forces.

FIG. 10.1 — HYATT REGENCY WALKWAY HANGER ROD CHANGE: SINGLE CONTINUOUS ROD (1P) VS. TWO OFFSET RODS (2P)

That two-rod substitution fundamentally altered the free-body static equilibrium of the fourth-floor box beam. It was the mechanical equivalent of two climbers hanging from a cliff where the lower climber lets go of the main rope and grips the upper climber's boots instead. In the original continuous-rod design, the second-floor dead and live load P_{lower} traveled straight up the steel rod to the roof truss without loading the fourth-floor beam connection:
