Quillmere Harbour Survey

The Quillmere harbour authority commissioned this survey after the storm season of the previous winter. Surveyors walked every pier, counted every bollard and logged the depth of the channel at low tide. Their notes describe a working harbour with old timber, new cranes and a lighthouse that still turns by clockwork.

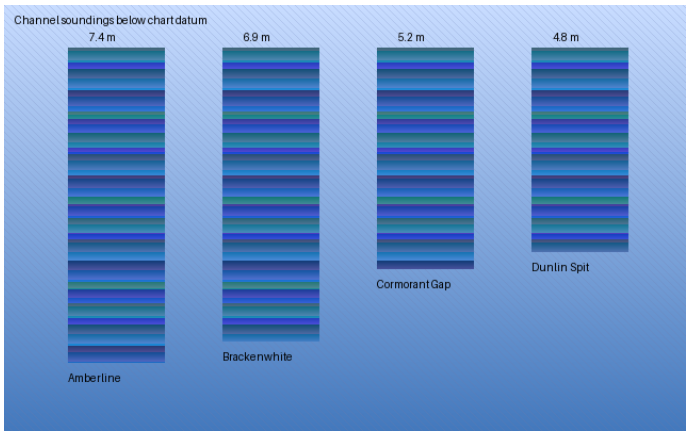
Figure 1: Soundings chart

The shallowest reading lies off Dunlin Spit, where silt from the Merrow estuary settles after heavy rain. The pilots asked for a dredging campaign to restore the charted depth of six metres before the larger grain ships begin calling at the harbour.
