Quillmere Harbour Survey

The Quillmere harbour authority commissioned this survey after the storm season of the previous winter. Surveyors walked every pier, counted every bollard and logged the depth of the channel at low tide. Their notes describe a working harbour with old timber, new cranes and a lighthouse that still turns by clockwork.

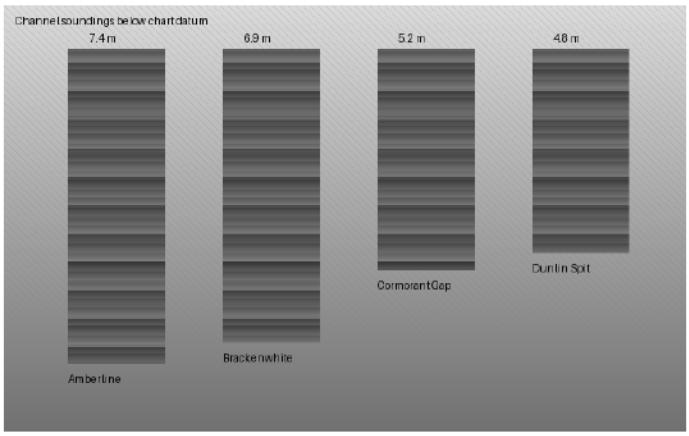
Figure 1: Soundings chart

The shallowest reading lies off Dunlin Spit, where silt from the Merrow estuary settles after heavy rain. The pilots asked for a dredging campaign to restore the charted depth of six metres before the larger grain ships begin calling at the harbour.

Replace the missing breakwater block, dredge the channel off Dunlin Spit, renew the worn mooring chains and test the foghorn air receiver. With these repairs the Quillmere harbour can serve the fishing fleet and the grain trade for another generation.
