T-BAT-CHARGER reports Battery Mismatch

FAQ\ BAT

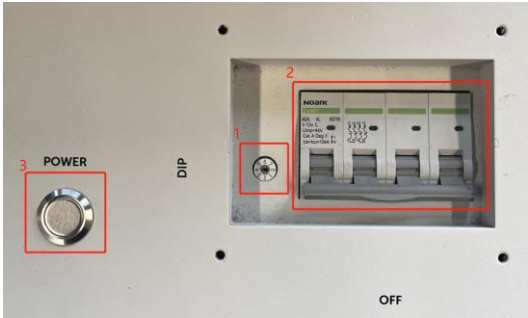
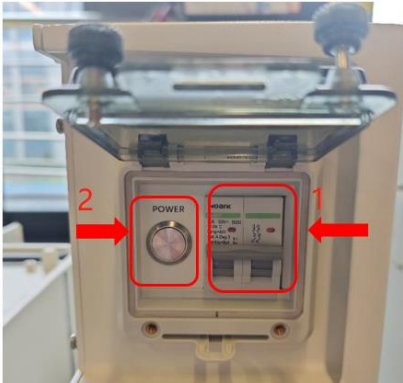
Step1: Perform a black start on the batteries, and measure the voltage. Take the T58 and T30 batteries as examples.

T58 battery master	T30 battery with BMS
1)Set the DIP switch to position '4' 2)Turn on the system by moving the circuit breaker switch to the on position; 3) Press the button. 	1)Move the circuit breaker switch to the on position to turn on the system; 2) Press the button and hold for 20 sec.
