HYDRONIC PRESSURE TEST
TEST REPORT

Project: ACNE Studio
Address: 82-84 Gansevoort Street, New York, NY
System: Supply and return piping loop serving (2) water source heat pump (WSHP) units
Date of test: 07/15/2026
Report issued: 10/15/2026

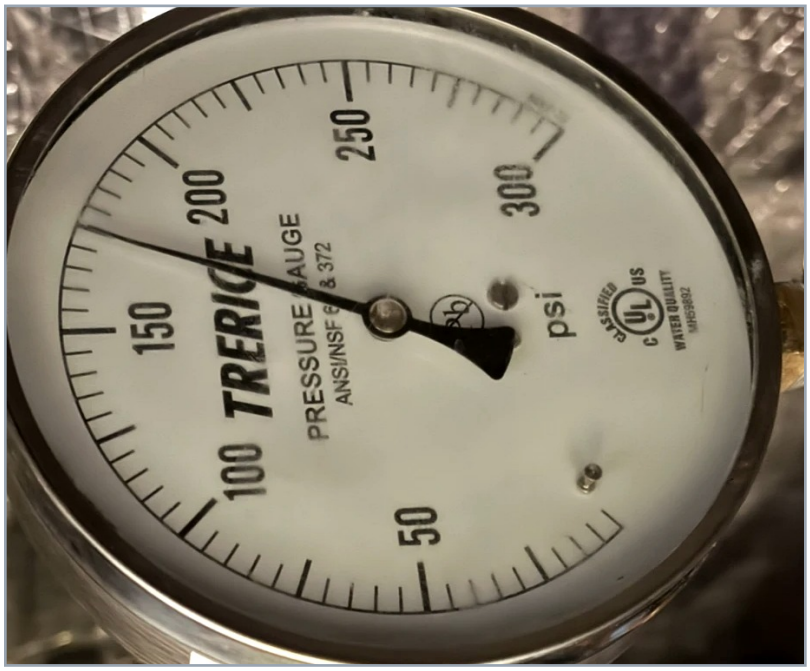
Test gauge reading 175 psig, 07/15/2026, 12:00 PM.
