BAY PROCEDURE

Tacoma RV Center · Document Library

CONCERN	FACR08 freeze up interior leak condensate		
MODEL	Furrion Chill rooftop unit	DATE	2026-09-19
PRIMARY	Furrion rooftop assembly and condensate path. Chill layout book for the pan and drain.		
		WO#	WO-FACR

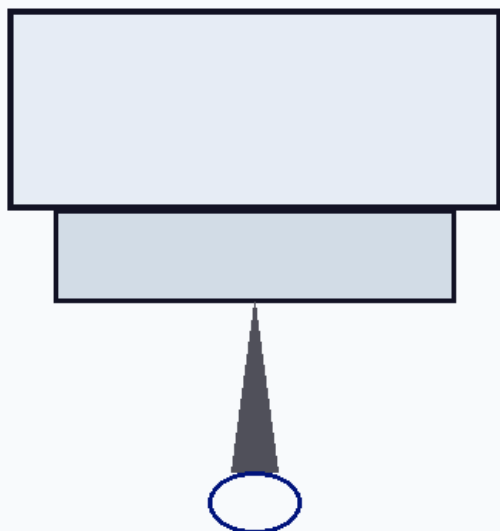
A Furrion rooftop freeze, interior leak, or condensate drip is an assembly and condensate problem. Prove the evaporator pan, the drain, the base-pan slope, and suction-line icing before you condemn the sealed system.

Inspect the evaporator pan and the condensate drain.

- ☐ 1. Inspect the rooftop assembly, the evaporator pan, and the condensate drain. If the drain is restricted or the pan is iced, clear the ice or the restriction and confirm water leaves the drain, then retest cooling. If the pan is dry and the drain is open, go to the next check.

If the drain is restricted or the pan is iced, clear it, then retest cooling.
