BAY PROCEDURE

Tacoma RV Center · Document Library

CONCERN	FACR08 freeze up interior leak condensate		
MODEL	Furrion Chill rooftop unit	DATE	2026-09-19
PRIMARY	Furrion rooftop assembly and condensate path. Chill layout book for the pan and drain.		
		WO#	WO-FACR

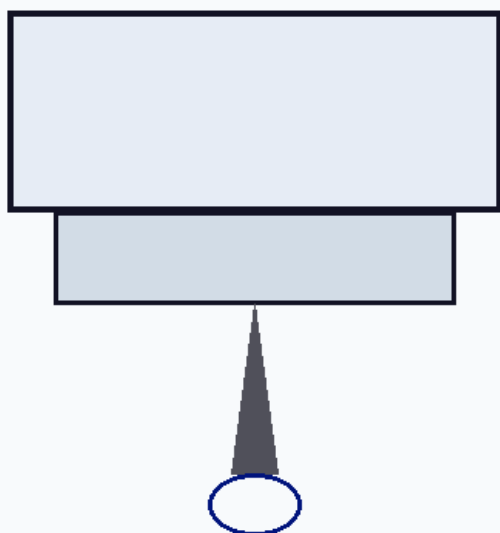
Inspect the evaporator pan and the condensate drain.

If the drain is restricted or the pan is iced, clear it, then retest cooling.
