BAY PROCEDURE

Tacoma RV Center · Document Library

CONCERN FACR08 freeze up interior leak condensate
MODEL Furrion Chill rooftop unit
PRIMARY Furrion rooftop assembly and condensate path. Chill layout book for the pan and drain.

WO# WO-FACR

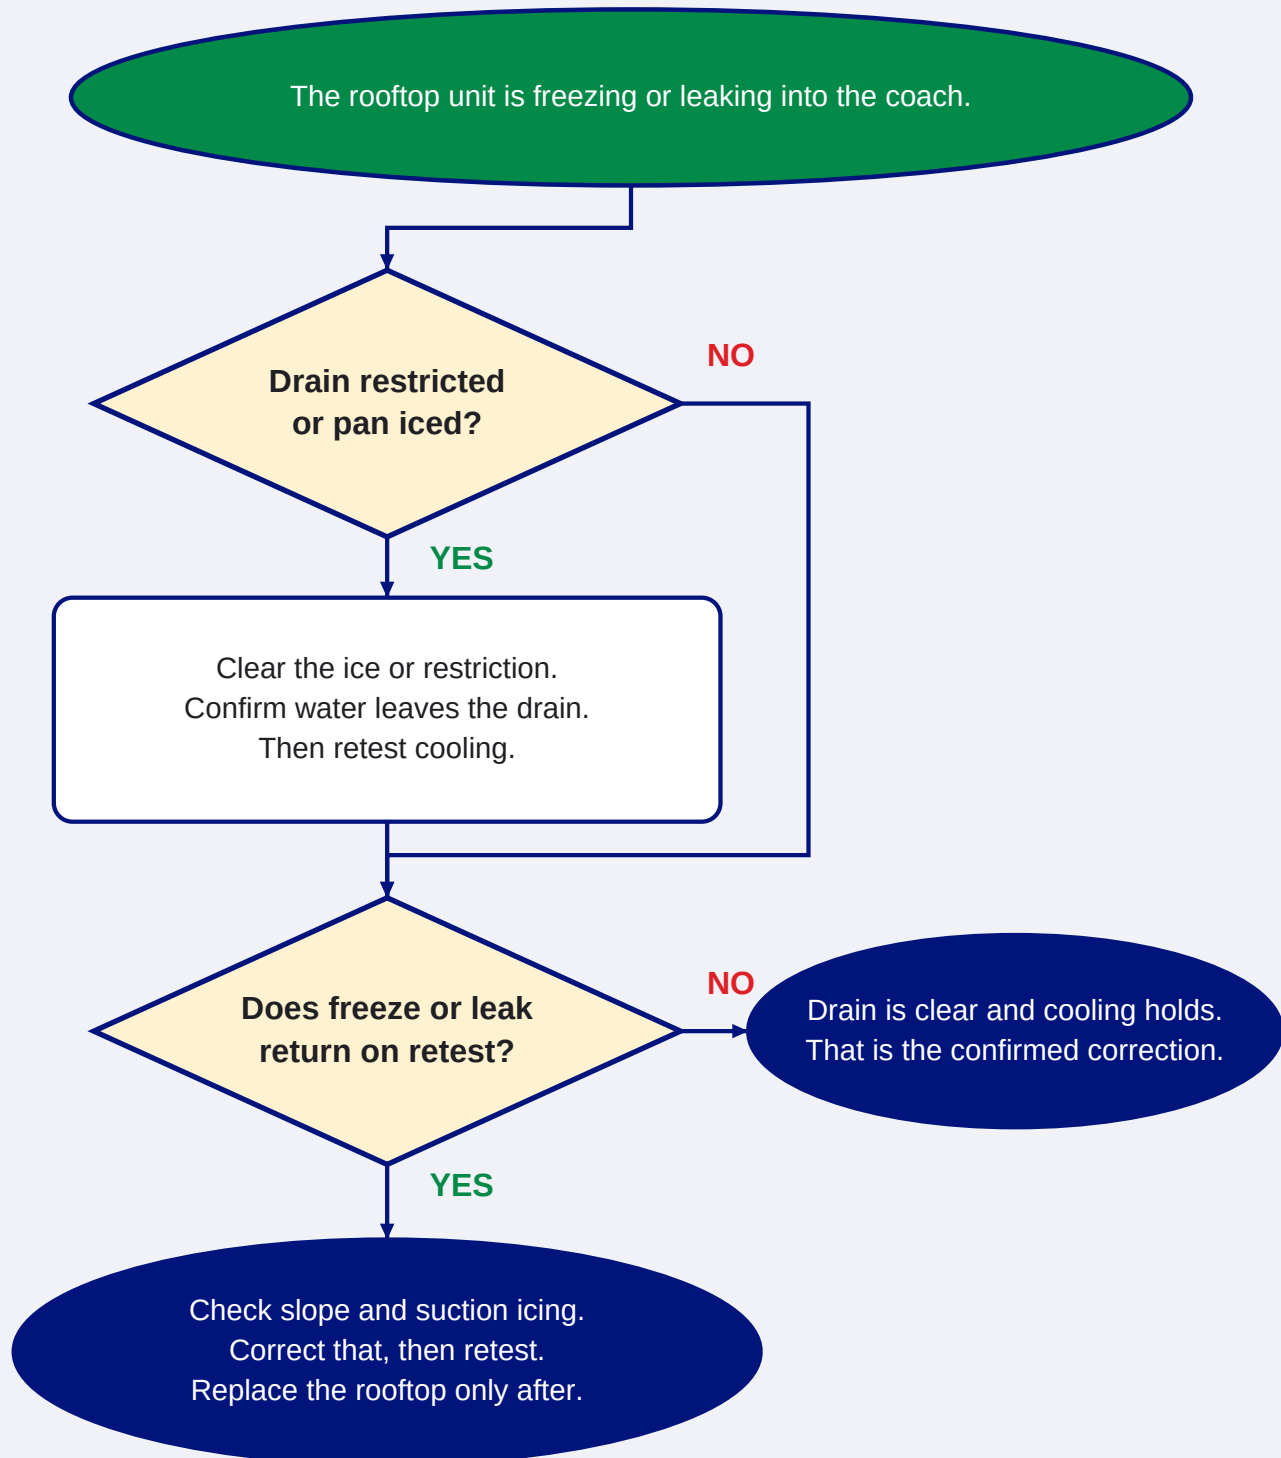
VISUAL FLOWCHART

A Furrion rooftop freeze, interior leak, or condensate drip is an assembly and condensate problem. Melt water that cannot leave the evaporator pan ices the pan, backs up, and drips into the coach. Prove the evaporator pan, the condensate drain, the base-pan slope, and suction-line icing before you condemn the sealed system. A clear drain and a dry interior after a full cool cycle is a passed assembly prove.

- ☐ 1. Inspect the rooftop assembly, the evaporator pan, and the condensate drain. If the drain is restricted or the pan is iced, clear the ice or the restriction and confirm water leaves the drain, then retest cooling. If the pan is dry and the drain is open, go to the drain-path confirm next.

- ☐ 2. Confirm the drain path from the evaporator pan out of the rooftop. If melt water backs up, clear the trough and the hose, then retest cooling. Water leaving freely is a pass: run cooling and watch the pan. Water that stands or overflows is a fail: stay on the drain until it leaves.

- ☐ 3. Watch the pan and the freeze-sensor area through a full cool cycle. If ice reforms in the pan or the drain ices shut, clear it again and prove the drain remains clear on the next cycle. If the drain remains clear and the pan stays dry, check the base-pan slope next.

- ☐ 4. Check the base-pan slope. If the pan is tilted so water cannot reach the drain, correct the slope and retest cooling. If the pan is level and water still reaches the drain, check suction-line icing next.

- ☐ 5. Check the suction line for icing. If the suction line is iced, correct that icing and retest cooling. If the suction line is clear, run a full cool cycle and watch the interior.

- ☐ 6. Retest cooling and watch the pan and the interior. If the freeze or leak is gone, the correction is the drain, pan, slope, or suction work you just proved. You are done.

- ☐ 7. If ice or drip returns with a clear drain, a level base pan, and a clear suction line, replace the rooftop unit after that assembly prove. That is the confirmed correction.

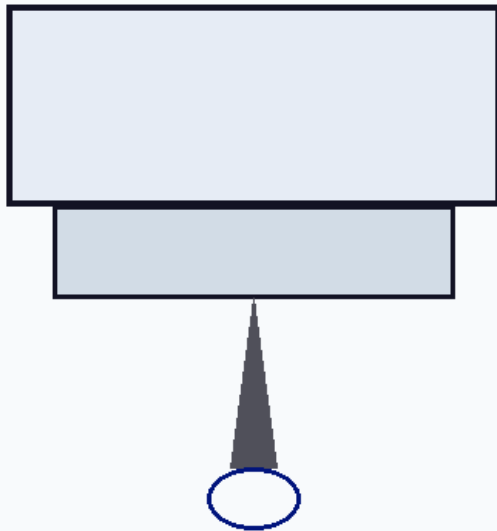
- Do not condemn the sealed system before you clear the drain and the pan
