# TECHNICAL BULLETIN

JTB00344NAS1  
06 MAY 2014

### Earth Stud Repair on Aluminum Body

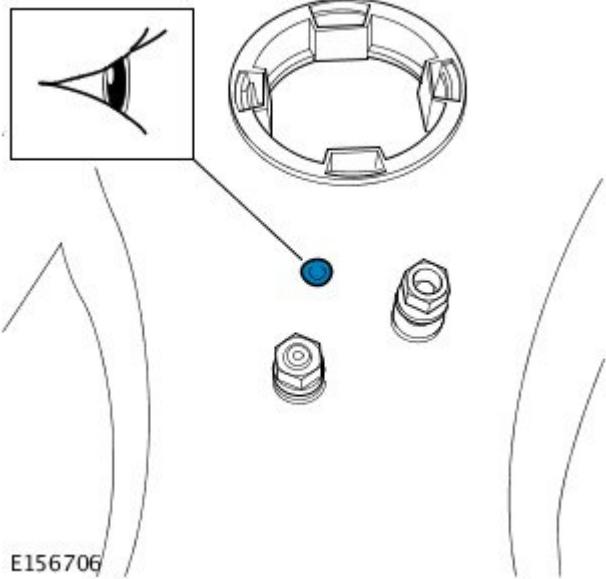
E161219

**2.** Locate broken/cross threaded earth stud.

**3.** Dress/file the broken stud to a safe and acceptable repair standard.

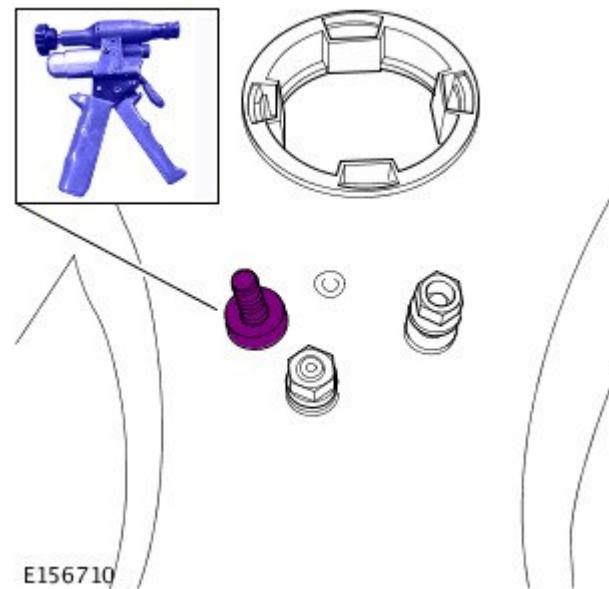
**7. Repaired earth stud with harness fitted.**

- Place the new stud into the drilled hole.
- Apply pressure to the trigger of the applicator gun until the pressure reduces, indicating the applicator gun has reached the end of its cycle.

- Torque 9Nm
