FLUID LEAKS [G2224785]

GENERAL PROCEDURE - FLUID LEAK DETECTION

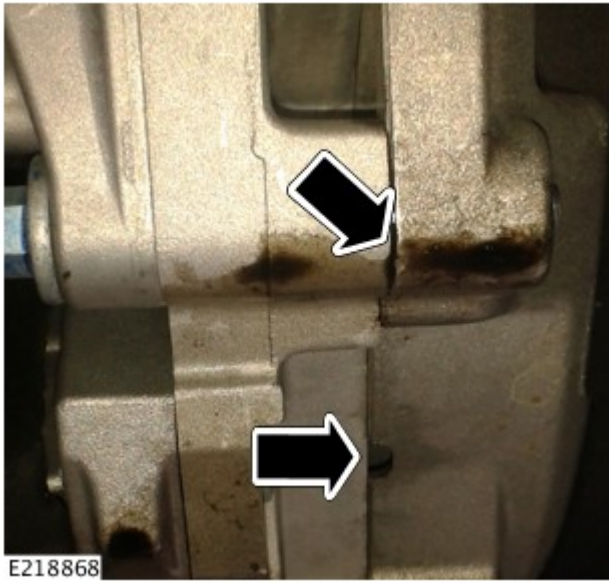
Engine oil leak example graphic. Oil is present between the engine and transmission mating faces, including evidence of oil in the 3 breather holes

8. Report or repair the source of the fluid leak

9. If no leak is found, continue diagnosis until the exact source of the leak is found
