Vehicle Damage Assessment Report

Name	John
Surname	Doe
Make	kia
Model	sportage
Year	2022
VIN	IT12345

Vehicle Damage Assessment Report Report Date: 2025-08-23 Prepared for: John Doe

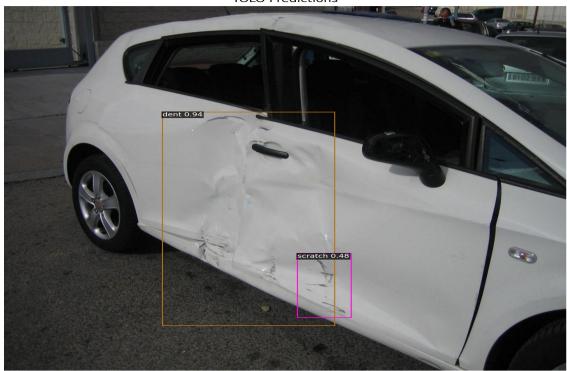
Detected Damages: - Dent in front door (conf=0.94, IoU=0.40) — Estimated Cost: \$427.58. See attached image. - Scratch in front door (conf=0.48, IoU=0.09) — Estimated Cost: \$428.62. See attached image.
