Executive Summary — Plant, Ductwork & Seismic Bracing

PROJECT The Garema Hotel (5-Star), ACT	PRINCIPAL CONTRACTOR TP Dynamics	MECHANICAL CONTRACTOR Climatech	SITE SUPERVISOR Keith Morgan
WORKS BY SA Quality Ductwork	REPORTING PERIOD Thu 20 – Wed 26 Aug 2026	SITE CREW P. Agosto, L. Taipe, Eduardo, Anthony	PREPARED BY P. Agosto & L. Taipe

Works Summary Report 02

THE GAREMA HOTEL · 20-26 AUG 2026

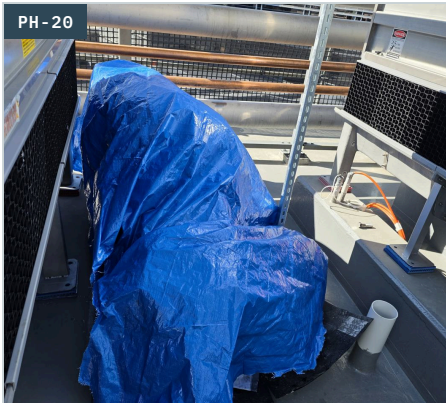
Stored plant covered

Relocated plant covered on the rooftop deck, clear of walkways.

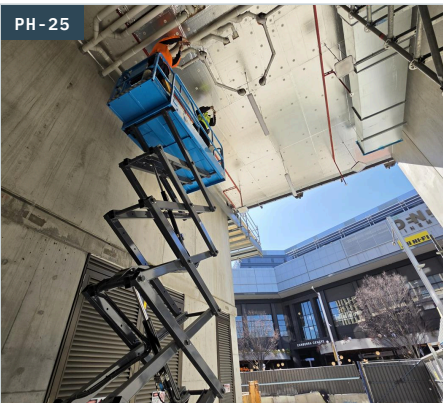
Ductwork down to Basement 3

All Ground Floor ductwork taken down and re-stored in Basement 3.

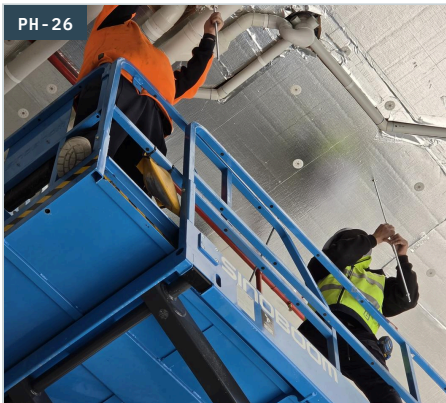
EWP set up at Level 1

Scissor lift set up for the changeover between Level 1 and the scaffold.
