Executive Summary — Plant Equipment, Unit Installation & Ductwork

PROJECT The Garema Hotel (5-Star) · Canberra ACT	PRINCIPAL CONTRACTOR TP Dynamics	MECHANICAL CONTRACTOR Climatech
SITE SUPERVISOR Keith Morgan — Climatech	WORKS BY SA Quality Ductwork	REPORTING PERIOD Thu 20 – Wed 26 Aug 2026
SITE CREW P. Augusto, L. Taipe, Eduardo, Anthony	PREPARED BY Pablo Augusto, Supervisor	PHOTOGRAPHIC RECORD 15 records — PH-01 to PH-15

Works Summary Report 02

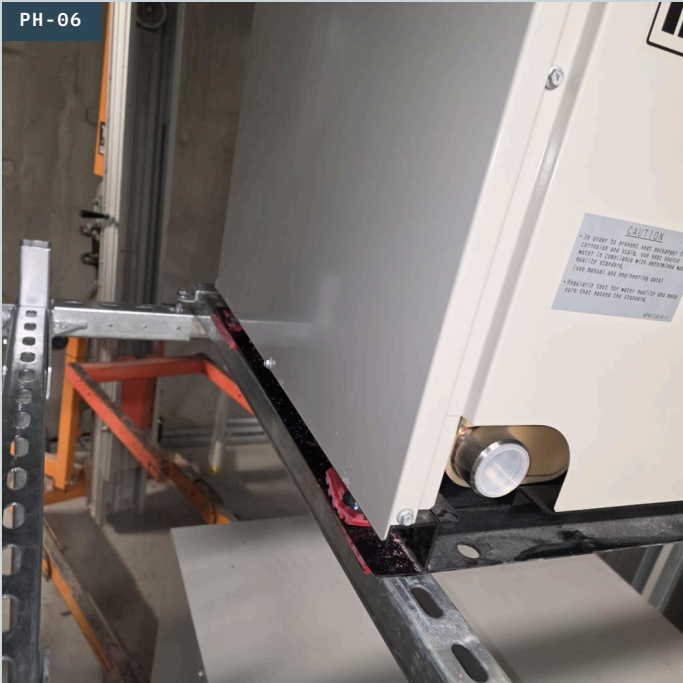
Anti-vibration pads at unit base

Continuous rubber AV pads fitted between the unit base rail and the steel support so the unit bears fully on the isolator — an acoustic requirement for the guest floors.

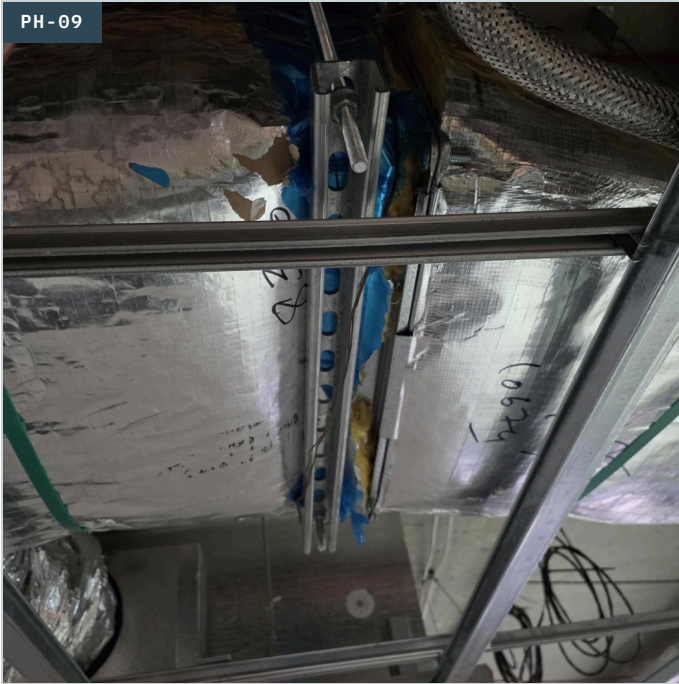
Insulated duct transition installed

Insulated rectangular duct and transition to spiral installed and supported on unistrut, set out to clear the hydraulic and fire services running above.
