DEEP LEARNING-BASED THERMAL FAULT DETECTION

University Engineering Checkpoint • Task–4 Diagnostic Inspection Report

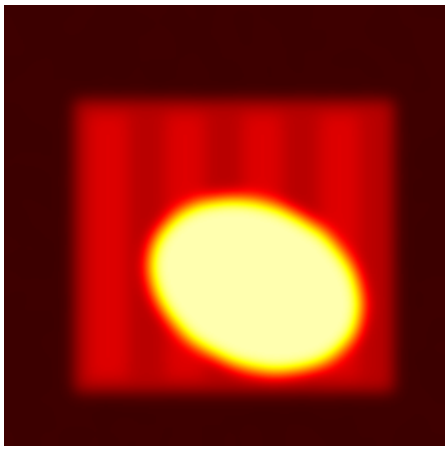
Original Thermal Acquisition

Analysis ID:	811ed993	**Inspection Date:**	2026-11-01 09:51:14 IST
Target Filename:	sample_overheating_1.png	**Model Architecture:**	v1.0-ONNX
Analysis Status:	SUCCESS	**Diagnostic Condition:**	Fault Detected
Classified Fault:	Abnormal Hotspot	**Model Confidence:**	99.90%
Assessed Severity:	Critical	**Resolution (Orig/Proc):**	320 x 320 px / 224 x 224 px

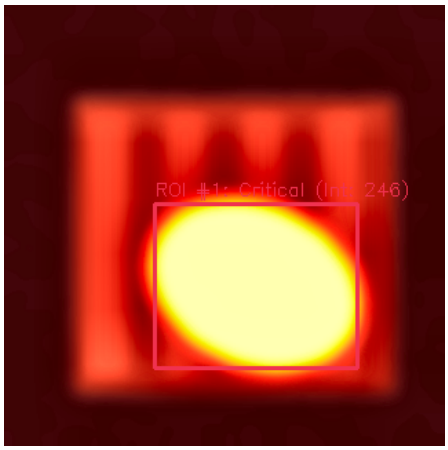
OpenCV Processed & Hotspot ROI

Region	Bounding Box (X,Y,W,H)	Peak Intensity	Area (Pixels)	Local Severity
Primary Hotspot	[109, 144, 147, 119]	246.0	13087 px	Critical
