THERMAL FAULT DIAGNOSTIC REPORT

Automated Infrared Thermographic Analysis & Deep Learning Evaluation

Analysis ID:	afb84685-be2e-4b64-9233-24ea6663a0f8	**Timestamp:**	2026-10-14T13:33:54
Image Filename:	test_thermal_transformer.png	**Model Version:**	ResNet18-ThermalTransfer (v1.2.0-trained)
Condition:	**Fault Detected**	**Fault Class:**	**Abnormal Hotspot**
Confidence Score:	31.0%	**Severity Level:**	**Medium**

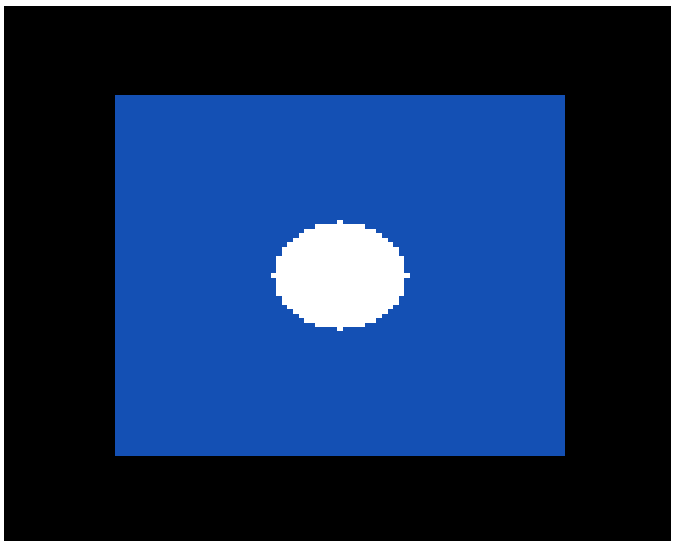
Figure 1: Original Thermal Image

Hotspot Bounding Box:	X: 47..74, Y: 47..74 (Width: 27px, Height: 27px)
Centroid Coordinates:	[60, 60] px
Peak Thermal Intensity Pixel:	[56, 51] px (Max Intensity: 255.0)
Relative Contrast / Area:	Contrast Ratio: +104.0% | Area Ratio: 8.35%

Summary: Moderate thermal anomaly identified (Abnormal Hotspot). Local hotspot exceeds equipment operating baseline by 104.0%. Schedule verification within standard maintenance cycle.

Next Actions: Schedule immediate physical inspection of identified terminal contacts. Verify torque on bolted electrical connections, inspect dielectric insulation, and measure phase current balance.
