# Site Validation Report

## Upson

92 Ben Hill Rd
Thomaston, GA 30286

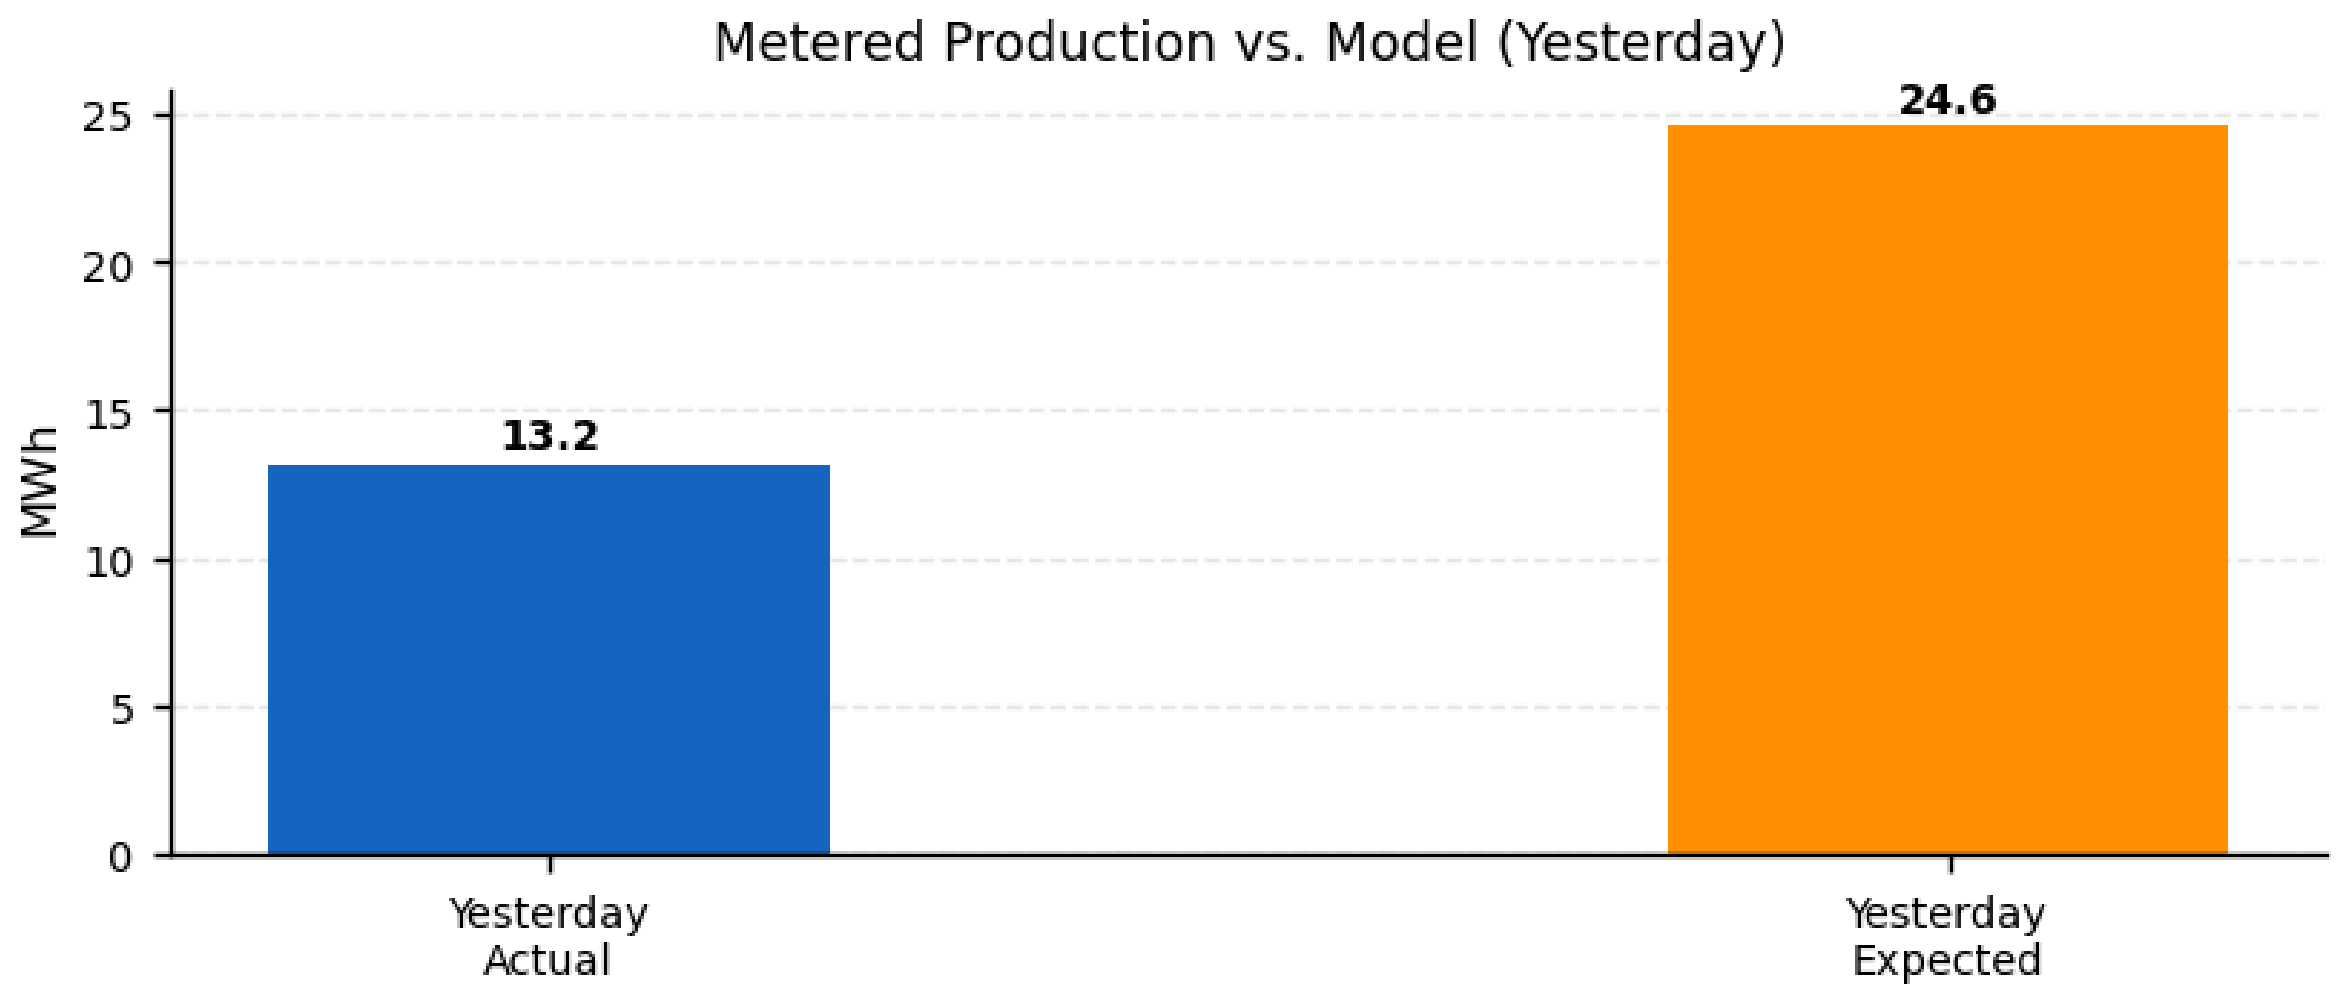
## PERFORMANCE

| Total Production | Expected Production* | Energy Ratio |
| 13,200 kWh | 24,569 kWh | 54 % |

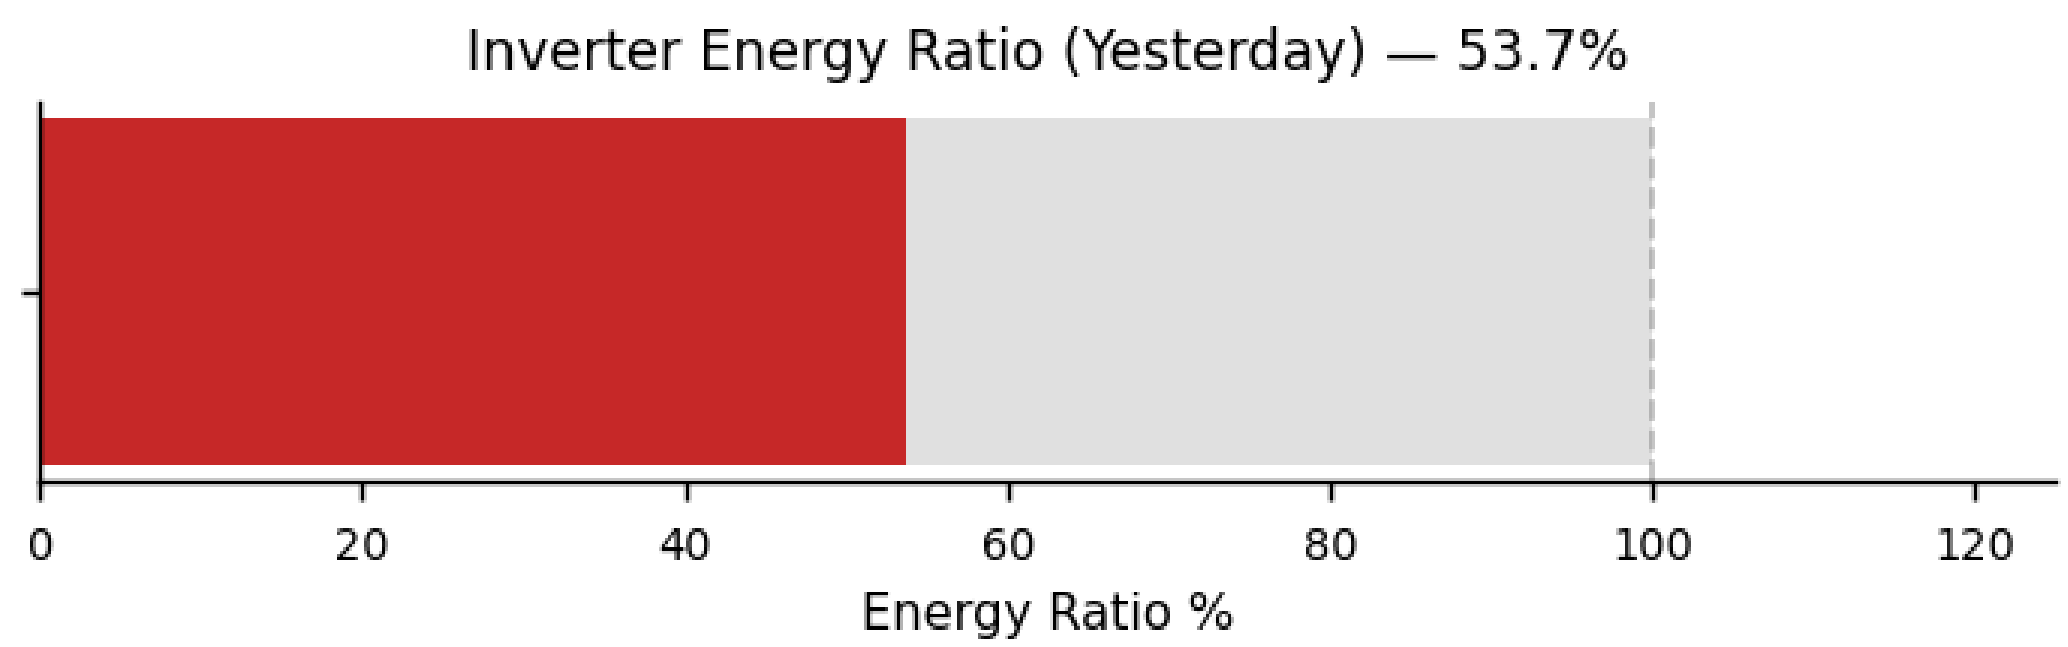
### Inverter Energy Ratio*

*Inverter Energy Ratio is based on Stem's PV model and weather data.
