Marina Gate 2 — Apt 2408

Snagging report · 6 Aug 2026, 09:41

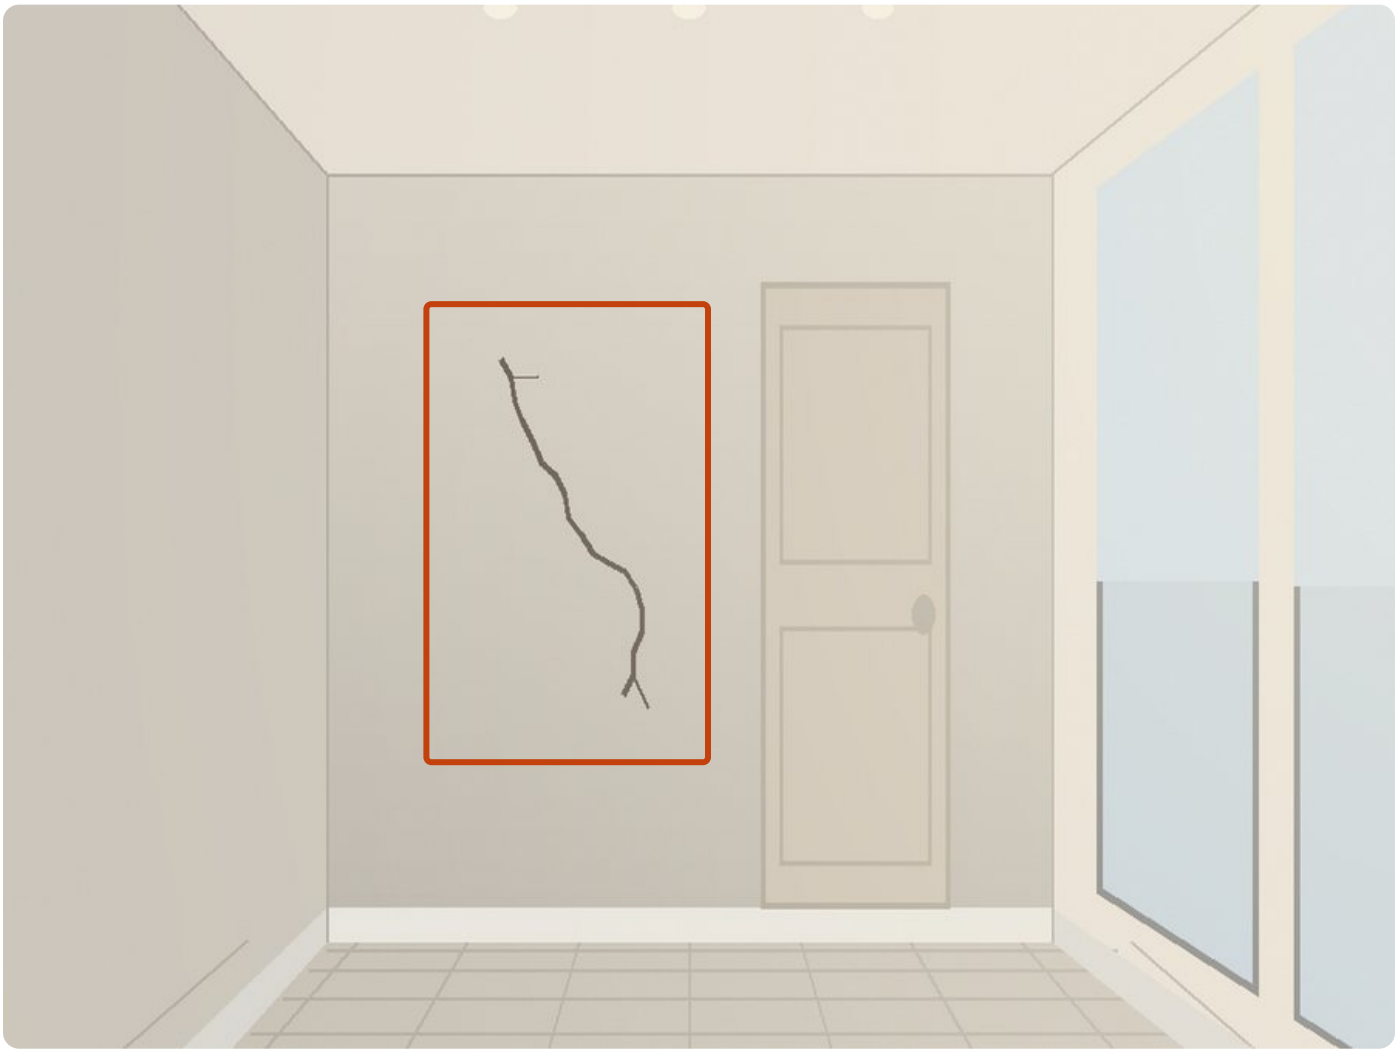
Living room

Diagonal crack at window reveal

MAJOR

A hairline-to-2mm crack runs diagonally from the upper corner of the window reveal across the plaster. Crack is continuous rather than a paint-only hairline, suggesting movement or inadequate bead fixing.

Recommended action: Rake out, fit mesh reinforcement over the reveal corner, re-skim and re-paint the full wall to avoid a patch line.
