Field Safety Notice

Urgent: Medical Device Correction – Pitch Cable Failures on da Vinci X and Xi Tenaculum Forceps and Small Graptor™ (ISIFA2024-10-C)

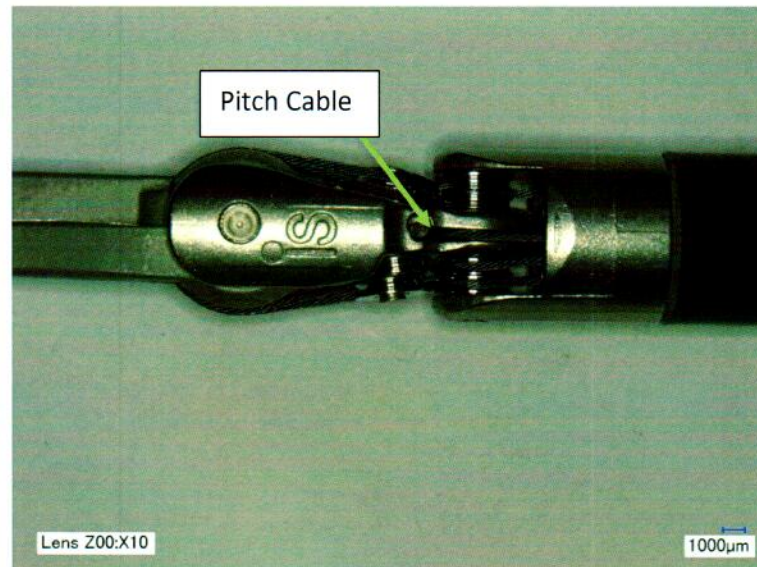
Figure A: 10x Magnified example of an intact pitch cable on an da Vinci Xi Tenaculum Forceps instrument.

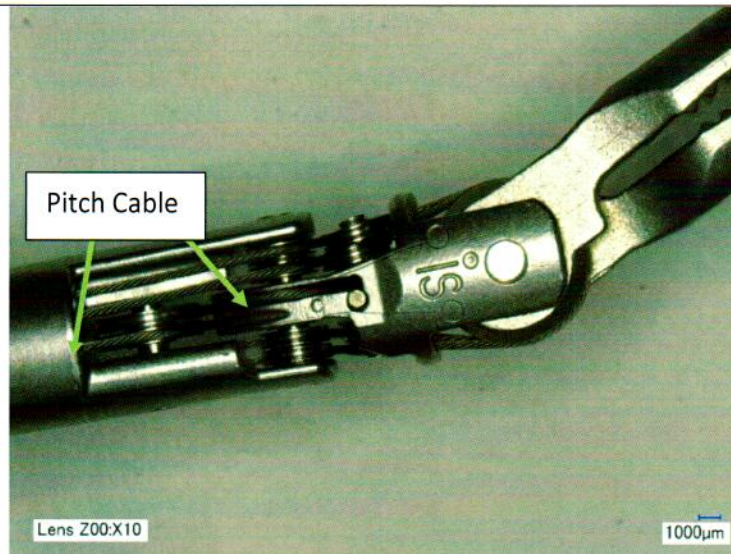
Figure B: 10x Magnified example of an intact pitch cable on an da Vinci Xi Small Graptor instrument.

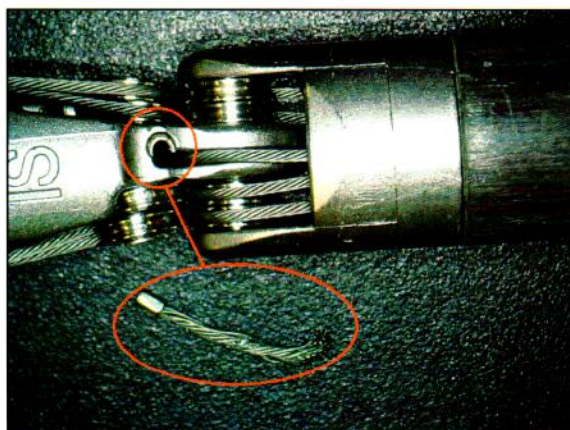
A pitch cable can fail partially (i.e., frayed) or completely (i.e., broken). A broken pitch cable can lead to loss of pitch functionality, exposure to frayed cables, or the potential for tungsten cable particulate to fall into the patient. Pitch cable failure may also result in a fragment of the pitch cable and its end-crimp becoming dislodged from the instrument (See Figure C).

Figure C: Example of a pitch cable fragment.

Both the Tenaculum Forceps and Small Graptor use an end crimp design at the distal end, where if the pitch cable breaks it is possible for a segment of the crimp side of the cable to fall out as a fragment and into the patient.

If you experience a cable failure, please be sure to inspect for any fragments before completing the procedure.

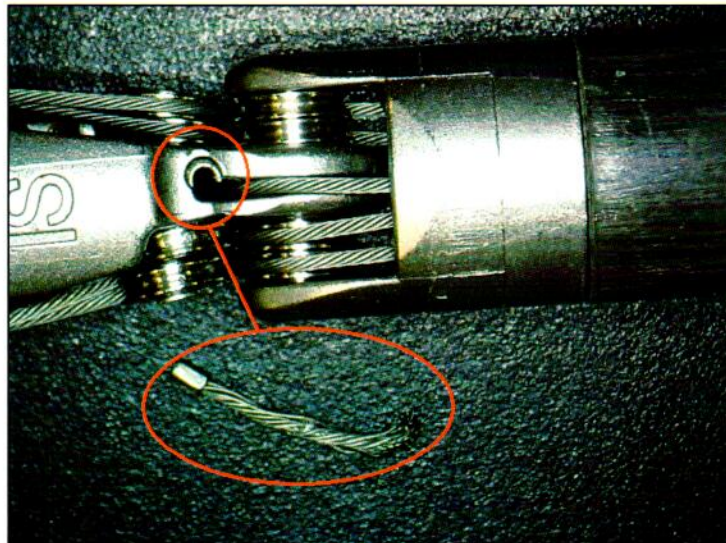
Figure E: Example of a pitch cable fragment.

Prior to use, visually inspect all instruments for broken or frayed cable per Figure E, F and G below

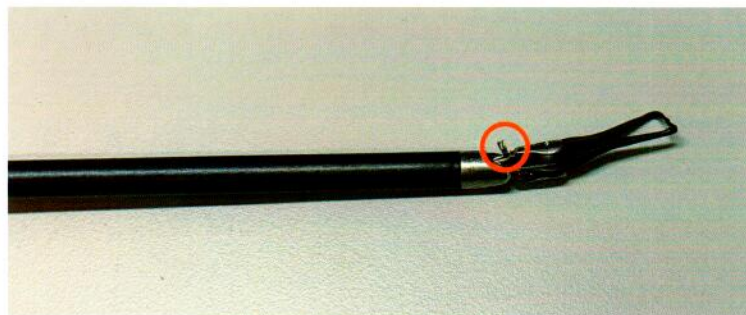
Figure F: Broken Pitch Cable

- If an instrument with a broken pitch cable is installed on the system, it could result in engagement failure which will be immediately detected by the surgeon.
- If a pitch cable breaks intraoperatively on an installed instrument, the failure would be immediately detected by the surgeon as it would result in imprecise motion. For example, the surgeon could command a motion at the hand controls, but the instrument may not respond as expected. Imprecise motion may manifest as reduced ability to retract tissue. If the affected instrument was grasping tissue at the time of cable breakage, the position of the grasped tissue may change due to gravity.

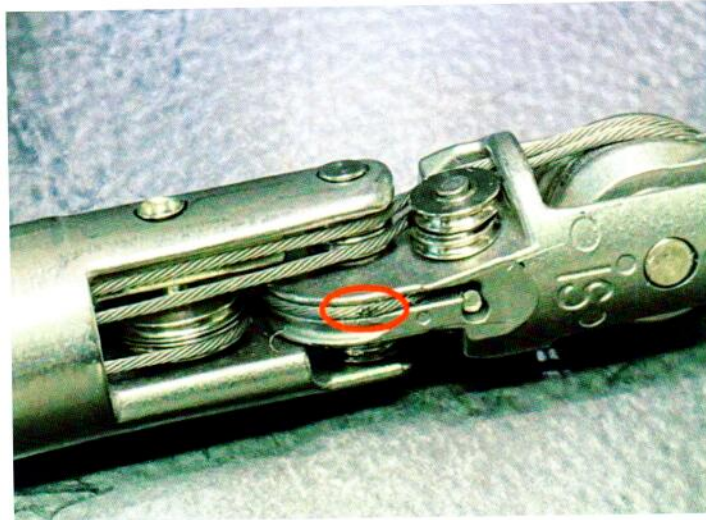
Figure G: Frayed Pitch Cable

- Frayed pitch cables may be identified through endoscopic view. Existing frayed pitch cable failure will not result in affected pitch motion as the pitch cable will remain connected.
- Frayed cables that are not visually identified would be unlikely to cause any unintended tissue interactions.
