DEVELOPMENT OF FUEL- AND COOLANT-SALT CENTRIFUGAL PUMPS FOR  
THE MOLTEN-SALT REACTOR EXPERIMENT

P. G. Smith

OCTOBER 1970

OAK RIDGE NATIONAL LABORATORY  
Oak Ridge, Tennessee  
operated by  
UNION CARBIDE CORPORATION  
for the  
U.S. ATOMIC ENERGY COMMISSION

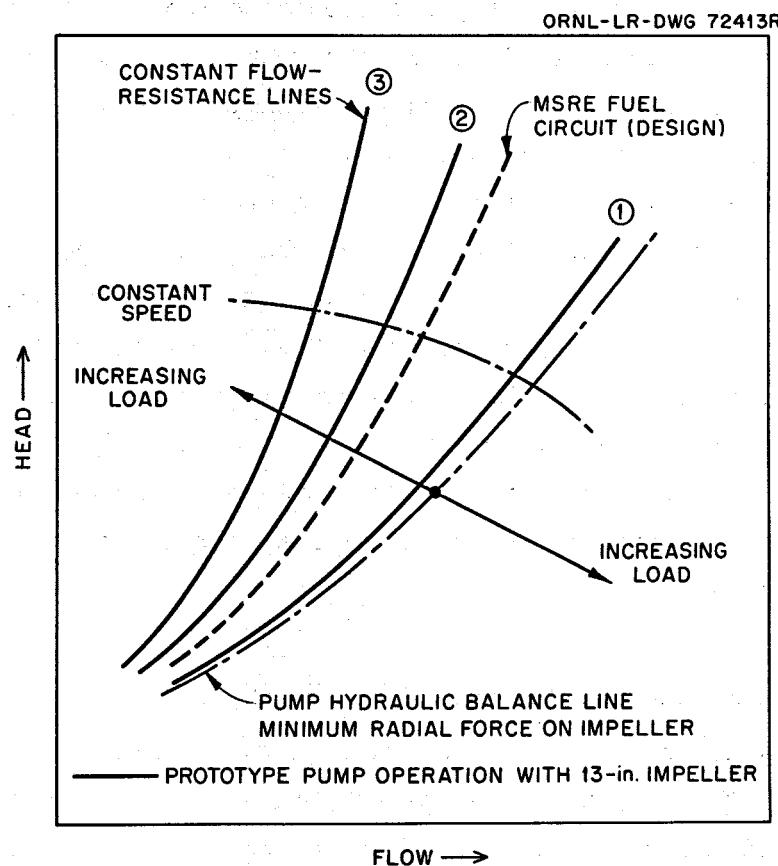
It is normal practice to try to operate centrifugal pumps at or near their highest efficiency. During operation along the constant system flow-resistance curve that passes through this best-efficiency point, also called the balance line (see Fig. 10), the various losses in the impeller and volute are minimum, and the pressure distribution in the volute is nearly uniform. This uniform distribution gives rise to the minimum net radial force on the impeller. During operation on higher or lower lines of system flow resistance (see Fig. 10), the volute pressure distribution becomes nonuniform, and a net radial force is exerted on the impeller that increases as the operating condition departs farther from the balance line. Thus operation at off-design conditions produces radial forces on the impeller that deflect the overhung shaft. Three incidents of insufficient running clearance to accommodate this deflection were encountered during operation of the MSRE pumps with molten salt in the test facility. During the initial molten-salt test (test 1, Table 1), the prototype pump shaft seized in the shield plug. Operation at off-design conditions deflected the shaft sufficiently to cause rubbing of the hot, dry shaft against the bore of the shield plug at its lower end. The shaft was friction-welded to the plug over a length of about 4 in. The radial running clearance between the shaft and the shield plug was

Fig. 10. Relationship Between Lines of Constant Flow Resistance, Pump Characteristic Curves, and Impeller Radial Load for Centrifugal Pumps.

therefore increased from 0.010 to 0.045 in. to avoid shaft seizure at anticipated off-design operating conditions.

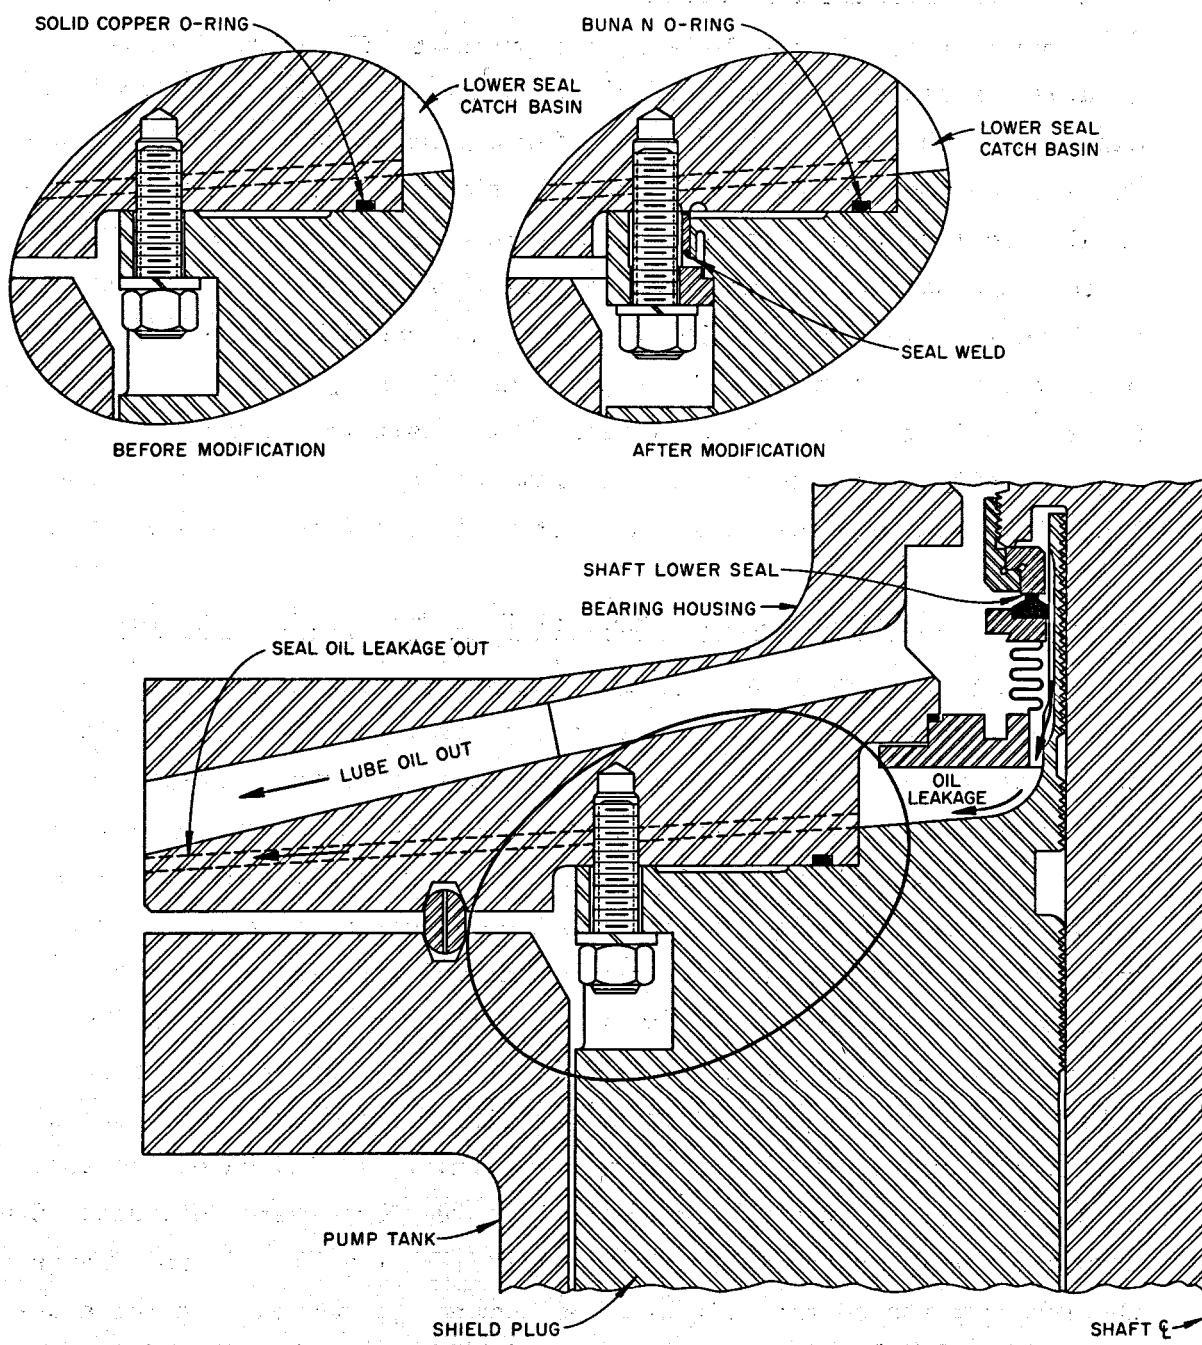
Oil leakage from the catch basin down the outside of the shield plug and into the pump tank was observed in some of the molten-salt pump tests and during initial operation of the fuel-salt pump with barren salt in the MSRE. The leakage path traversed a joint that was sealed with a soft-annealed solid-copper O-ring compressed between adjacent flat horizontal surfaces on the bearing housing and shield plug (see Fig. 11). Modifications were made on the spare rotary elements for the fuel and coolant pumps for the MSRE.

Fig. 11. Cross Sections of Catch Basin Region of Rotary Element Before and After Modification to Seal the Oil Leak Passage Between Shield Plug and Bearing Housing.

A weld arrangement was devised to seal the joint between the bearing housing and the shield plug in a positive manner. The relationships between the pump shaft, the shaft lower seal, bearing housing, catch basin, shield plug, and the pump tank are shown in the larger section in Fig. 11. The insets show the portions affected before and after modification. The modification was made on both the fuel- and coolant-salt pump spare rotary elements for the MSRE.

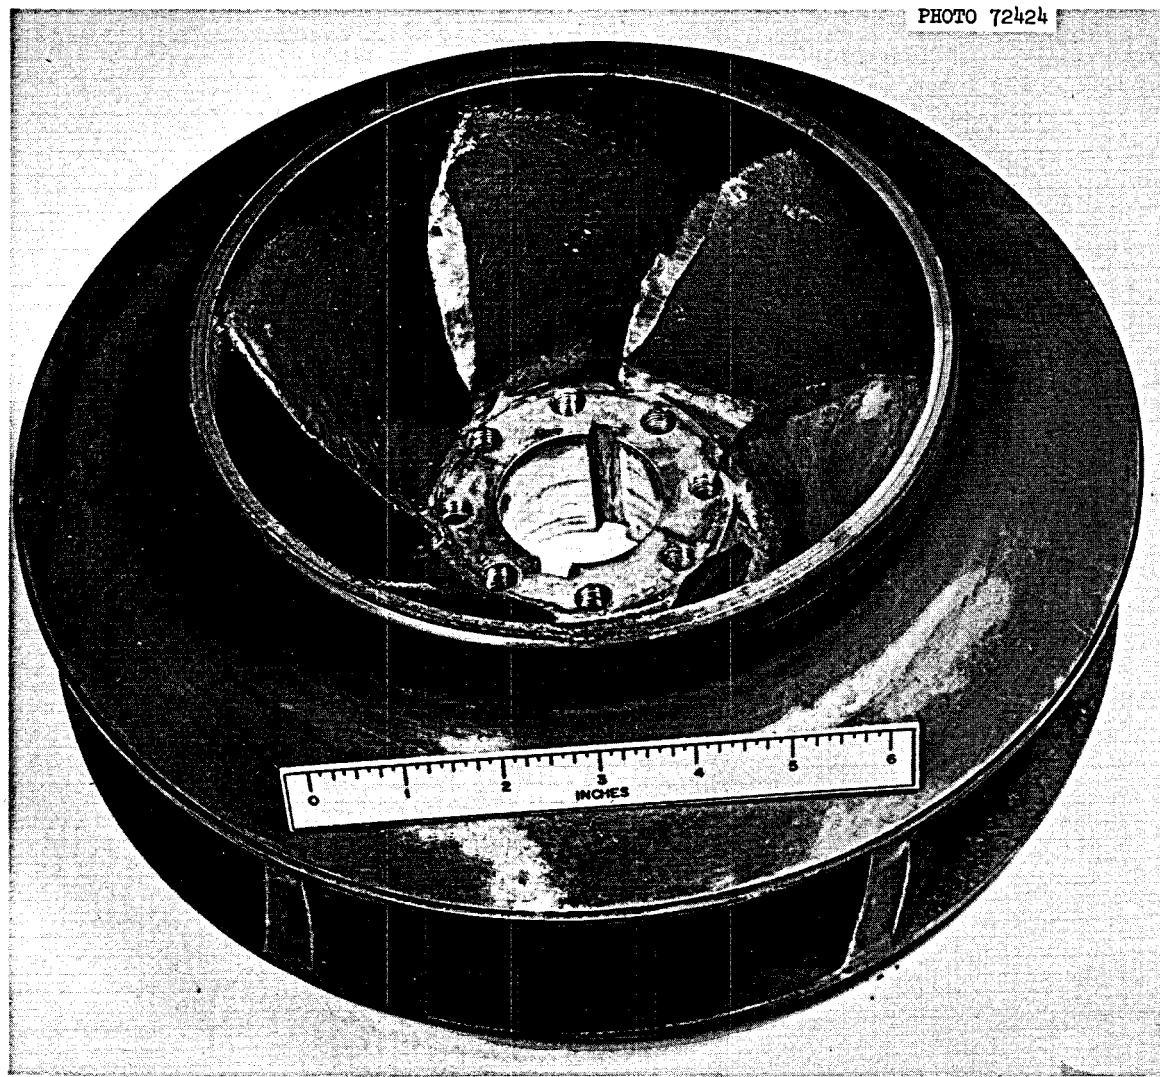
Test 12 (see Table 1) was terminated after the operator reported a strange noise that he had heard only one time. A slight roughening of the trace on the pump power recorder was also observed. Inspection indicated that one of the three parts of a flow-straightening device had become detached and lodged in the impeller inlet. This caused some damage to the inlet edges of the impeller vanes and deformed a swirl preventer of cruciform configuration that was located adjacent to the impeller inlet. Figure 12 shows the posttest configuration of one of the three parts from the straightener. Figure 13 shows the rubbing damage to the leading edges of the impeller vanes, and Fig. 14 shows the damage done to the swirl preventer. Figure 15 indicates the locations in the flow straightener from which the three parts were detached. Other than the barely perceptible roughening of the power trace, no effects of the lodged parts on the hydraulic performance of the pump could be detected.

Fig. 13. Rubbing Damage to Inlet Edges of Impeller Blades. Damage was caused by rubbing of impeller against detached part of flow straightener that lodged in impeller inlet.

At this time it was decided to modify the salt piping as shown in Fig. 16 to locate the venturi meter in the upper leg of the salt piping and the straightener upstream of it near the outlet end of the air cooler. The designs of the straightener and the welds joining its parts were also modified to reduce the vibration-induced fatigue thought to be the reason for the detachment of the three parts. The impeller and the swirl preventer were replaced also.

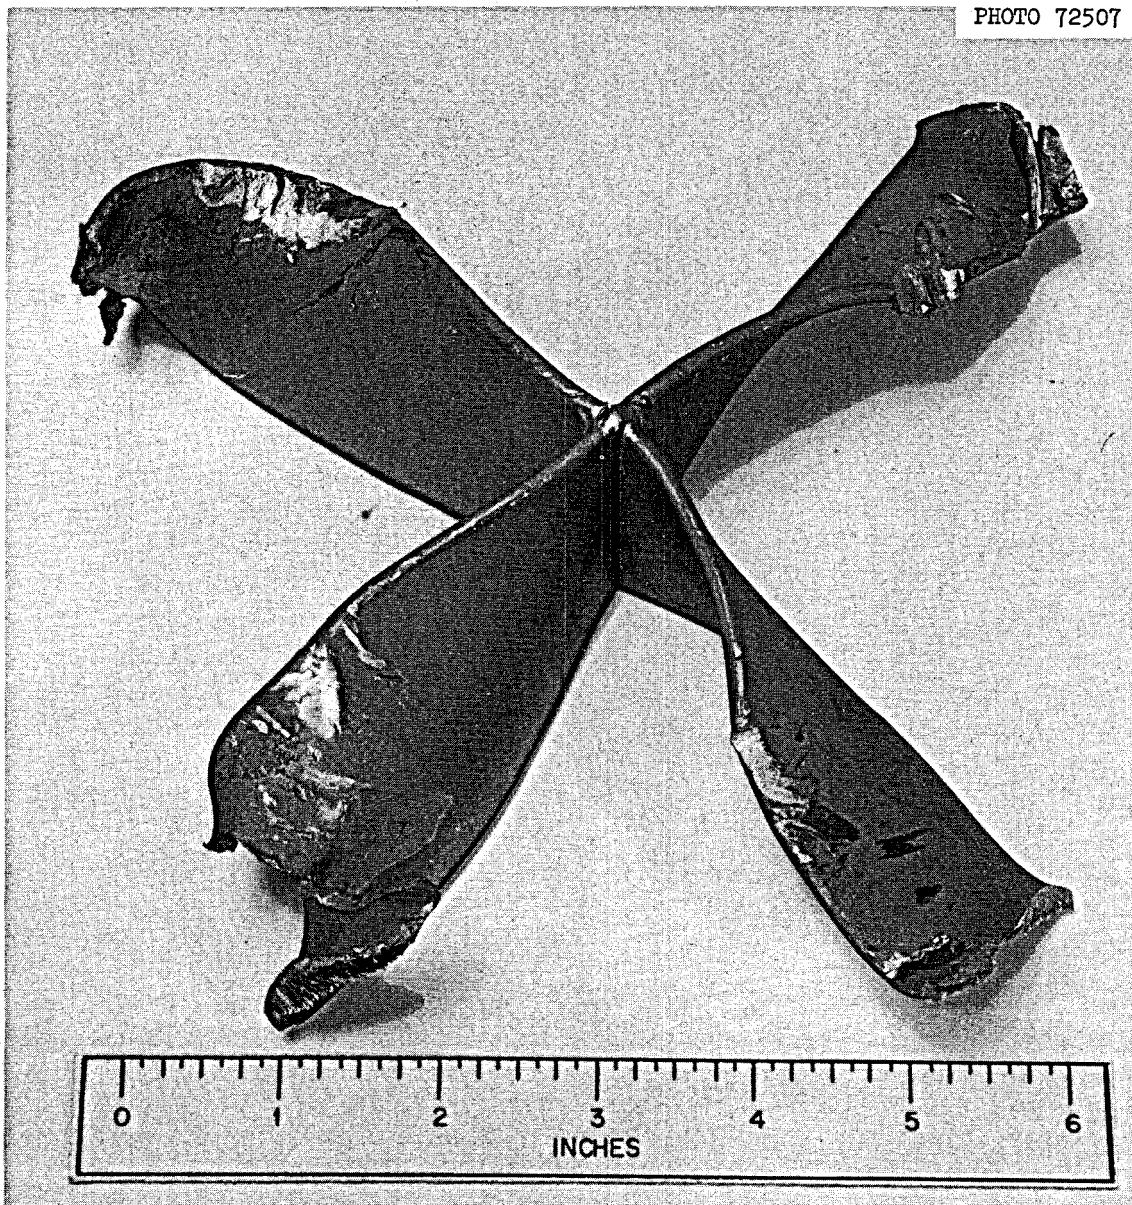
PHOTO 72507

Fig. 14. Damaged Swirl Preventer. Damage was caused by lodging of detached part of flow straightener in impeller inlet.

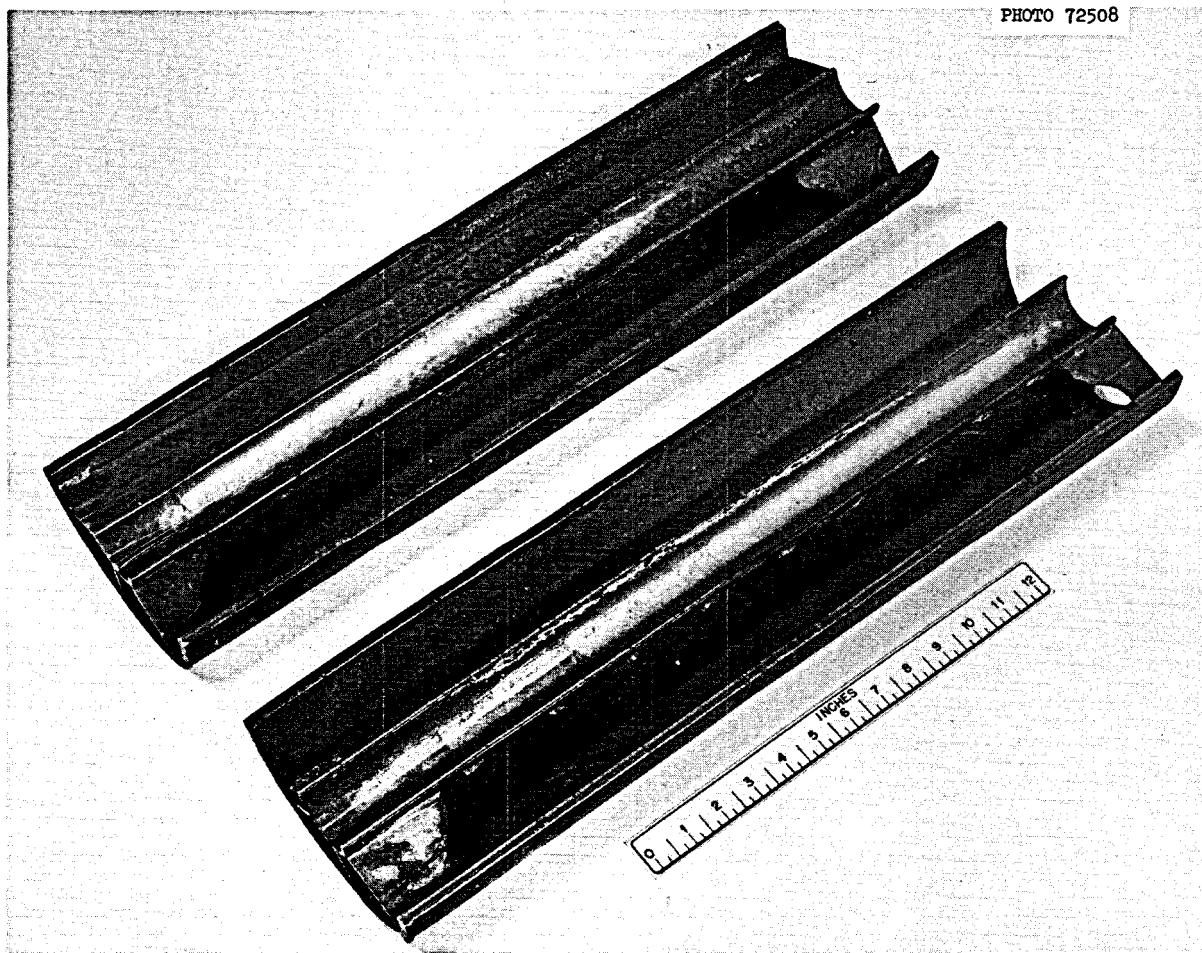
Fig. 15. Failure of Weld Attachment of Parts in Flow Straightener.  
Locations are shown from which parts were detached.

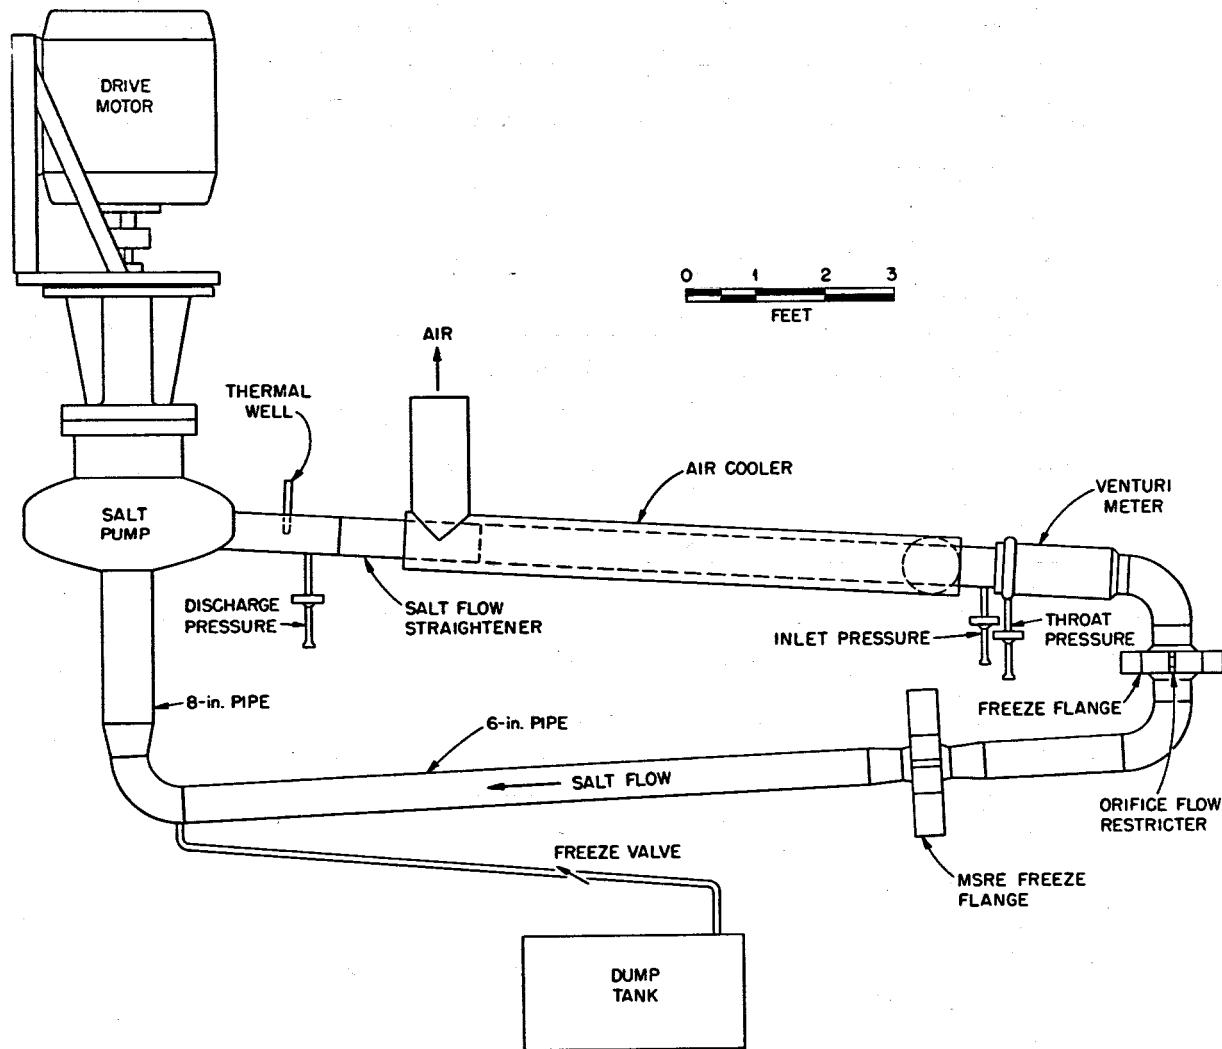
Fig. 16. Configuration of Salt Piping in the Molten-Salt Pump Test Stand as Modified After Failure of Weld Attachment of Parts in Flow Straightener.
