### **Apparent Impact Insulation Class (AIIC)**

**Report Date:** 2024-04-15 00:00:00 **Test Date:** 2024-04-04 00:00:00

DLAA Test No1.4.1Source Room:2nd Floor Bed 1Test SiteGentry aptsReceiver Room:1st Floor Bed 1ClientGentry BuildersTest Assembly:Floor-ceiling

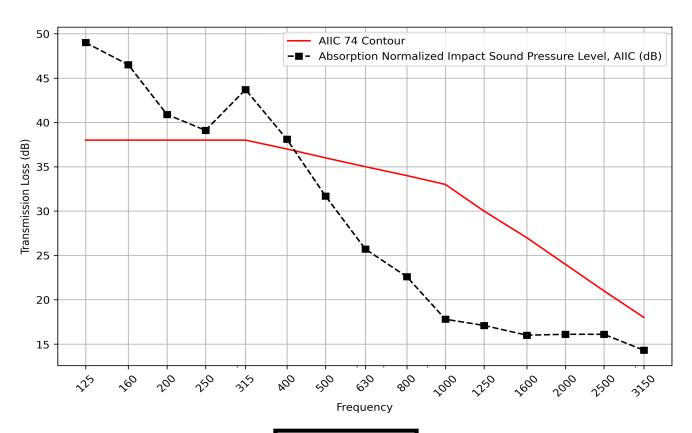
AIIC: 74

The Apparent Impact Insulation Class (AIIC) of 74 was calculated. The AIIC rating is based on Absorption Normalized Impact Sound Pressure Level (ANISPL), and includes the effects of noise flanking. The AIIC reference contour is shown on the next page, and has been fit to the Absorption Normalized Impact Sound Pressure Level values, in accordance with the procedure of ASTC Test Procedure ASTM E336-16 The results stated in this report represent only the specific construction and acoustical conditions present at the time of the test. Measurements performed in accordance with this test method on nominally identical constructions and acoustical conditions may produce different results.
