Report Date: 2024-04-15 00:00:00 Source Room: 2nd Floor Kitchen

Test Date: 2024-04-04 00:00:00 **Receiver Room:** 1st Floor Great Room/Kitchen

DLAA Test No 1.2.1 Test Assembly: Floor-ceiling

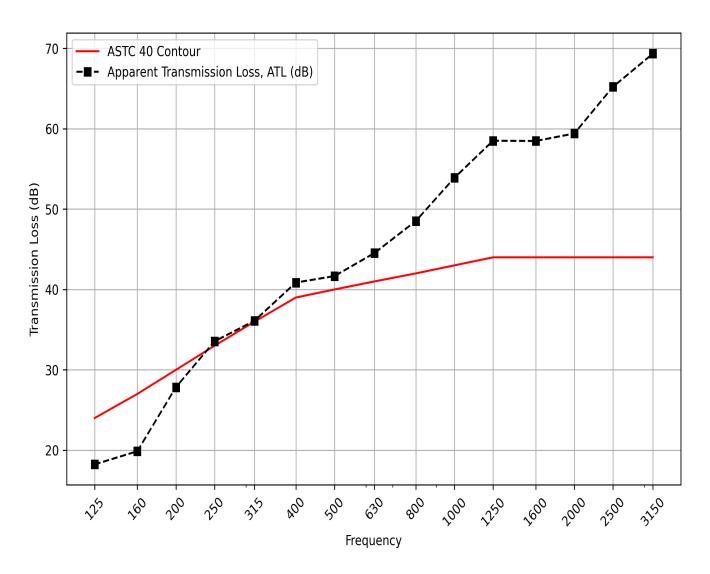
The Apparent Sound Transmission Class (ASTC) of 40 was calculated. The ASTC rating is based on Apparent Transmission Loss (ATL), and includes the effects of noise flanking. The ASTC reference contour is shown on the next page, and has been "fit" to the Apparent Transmission Loss values, in accordance with the procedure of ASTC Test Procedure ASTM E336-16
