Report Date: 2024-04-15 00:00:00 **Test Date:** 2024-04-04 00:00:00

DLAA Test No 1.2.1 **Source Room:** 2nd Floor Kitchen

Test Site Gentry apts Receiver Room: 1st Floor Great Room/Kitchen

Client Gentry Builders Test Assembly: Floor-ceiling

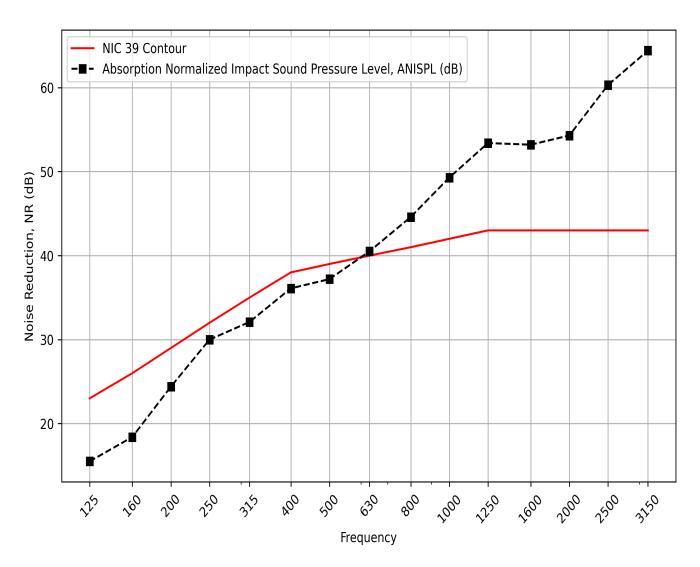
The Noise Isolation Class (NIC) of 39 was calculated. The NIC rating is based on Noise Reduction (NR), and includes the effects of noise flanking. The NIC reference contour is shown on the next page, and has been "fit" to the Noise Reduction values, in accordance with the procedure of ASTC Test Procedure ASTM E336-16. The results stated in this report represent only the specific construction and acoustical conditions present at the time of the test. Measurements performed in accordance with this test method on nominally identical constructions and acoustical conditions may produce different results.
