Report Date: 2024-04-15 00:00:00 Source Room: 2nd Floor Kitchen

Test Date: 2024-04-04 00:00:00 **Receiver Room:** 1st Floor Great Room/Kitchen

DLAA Test No 1.2.1 Test Assembly: Floor-ceiling

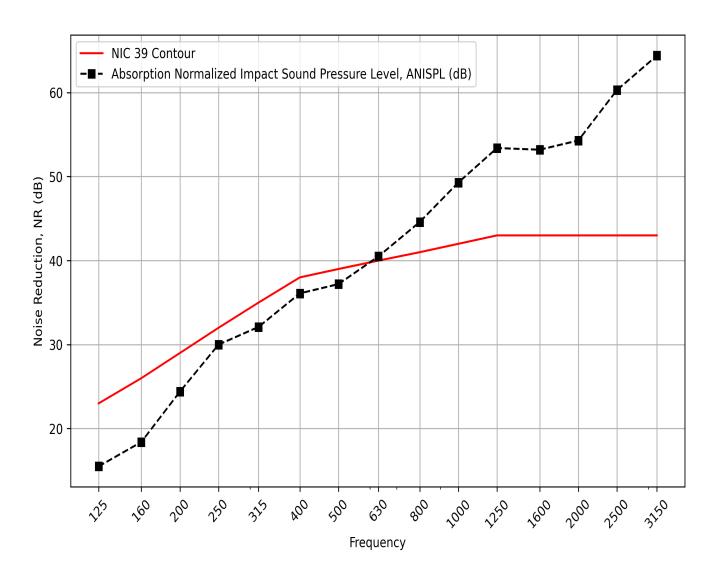
STATEMENT OF TEST RESULTS:

The Noise Isolation Class (NIC) of 39 was calculated. The NIC rating is based on Noise Reduction (NR), and includes the effects of noise flanking. The NIC reference contour is shown on the next page, and has been "fit" to the Noise Reduction values, in accordance with the procedure of ASTC Test Procedure ASTM E336-16. The results stated in this report represent only the specific construction and acoustical conditions present at the time of the test. Measurements performed in accordance with this test method on nominally identical constructions and acoustical conditions may produce different results.
