**Report Date:** 2024-04-15 00:00:00 **Source Room:** 2nd Floor Great Room

**Test Date:** 2024-04-04 00:00:00 **Receiver Room:** 1st Floor Great Room/Kitchen

**DLAA Test No** 1.1.1 **Test Assembly:** Floor-ceiling

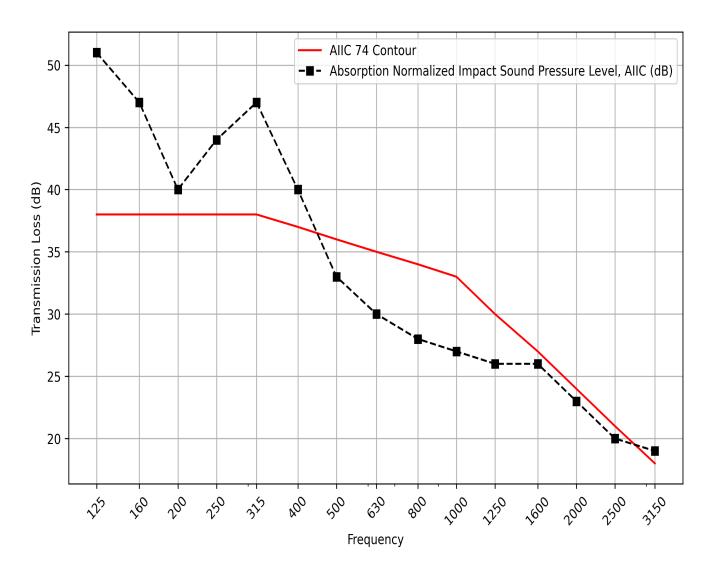
The Apparent Impact Insulation Class (AIIC) was calculated. The AIIC rating is based on Absorption Normalized Impact Sound Pressure Level (ANISPL), and includes the effects of noise flanking. The AIIC reference contour is shown on the next page, and has been "fit" to the Absorption Normalized Impact Sound Pressure Level values, in accordance with the procedure of ASTC Test Procedure ASTM E336-16 The results stated in this report represent only the specific construction and acoustical conditions present at the time of the test. Measurements performed in accordance with this test method on nominally identical constructions and acoustical conditions may produce different results.
