**Report Date:** 2024-04-15 00:00:00 **Source Room:** 2nd Floor Great Room

**Test Date:** 2024-04-04 00:00:00 **Receiver Room:** 1st Floor Great Room/Kitchen

DLAA Test No 1.1.1 Test Assembly: Floor-ceiling

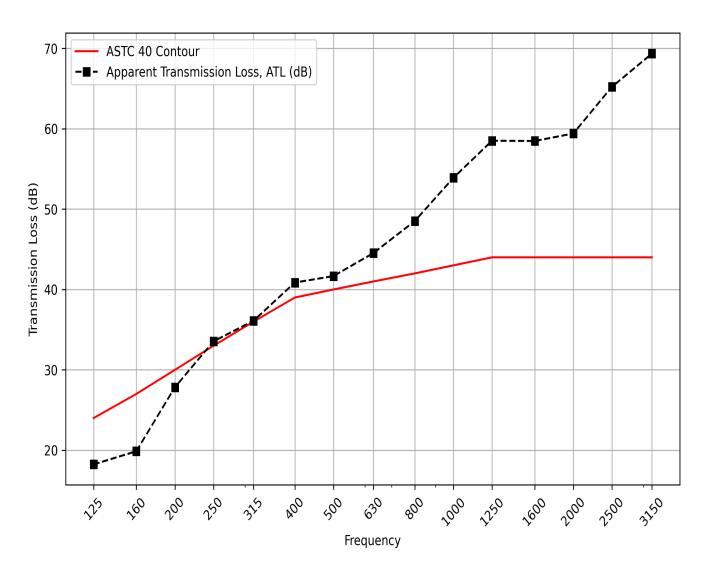
The Apparent Sound Transmission Class (ASTC) of 40 was calculated. The ASTC rating is based on Apparent Transmission Loss (ATL), and includes the effects of noise flanking. The ASTC reference contour is shown on the next page, and has been "fit" to the Apparent Transmission Loss values, in accordance with the procedure of ASTC Test Procedure ASTM E336-16
