Report Date: 2024-04-15 00:00:00 **Source Room:** 2nd Floor Great Room

Test Date: 2024-04-04 00:00:00 **Receiver Room:** 1st Floor Great Room/Kitchen

DLAA Test No 1.1.1 Test Assembly: Floor-ceiling

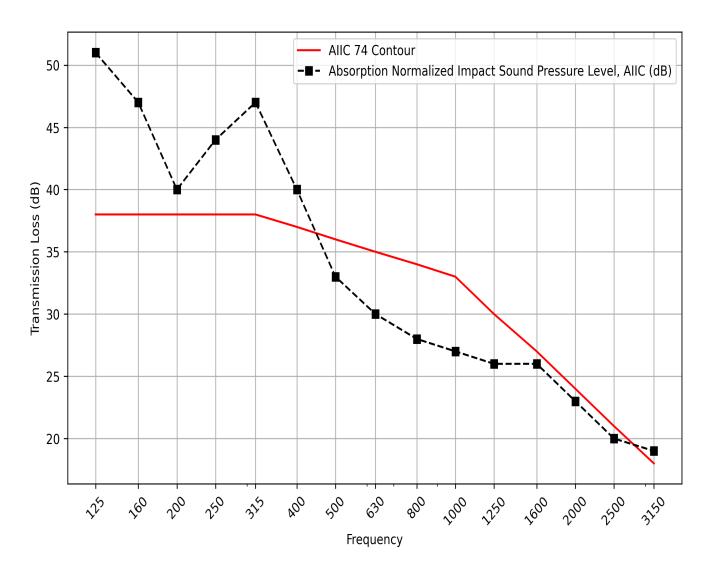
STATEMENT OF TEST RESULTS:

The Apparent Impact Insulation Class (AIIC) was calculated. The AIIC rating is based on Absorption Normalized Impact Sound Pressure Level (ANISPL), and includes the effects of noise flanking. The AIIC reference contour is shown on the next page, and has been "fit" to the Absorption Normalized Impact Sound Pressure Level values, in accordance with the procedure of ASTC Test Procedure ASTM E336-16 The results stated in this report represent only the specific construction and acoustical conditions present at the time of the test. Measurements performed in accordance with this test method on nominally identical constructions and acoustical conditions may produce different results.
