Field Sound Transmission Test Report

Apparent Sound Transmission Class (ASTC)

Report Date:	2024-04-15 00:00:00		
Test Date:	2024-04-04 00:00:00		
DLAA Test No	1.1.1	**Source Room:**	2nd Floor Great Room
Test Site	Gentry apts	**Receiver Room:**	1st Floor Great Room/Kitchen
Client	Gentry Builders	**Test Assembly:**	Floor-ceiling

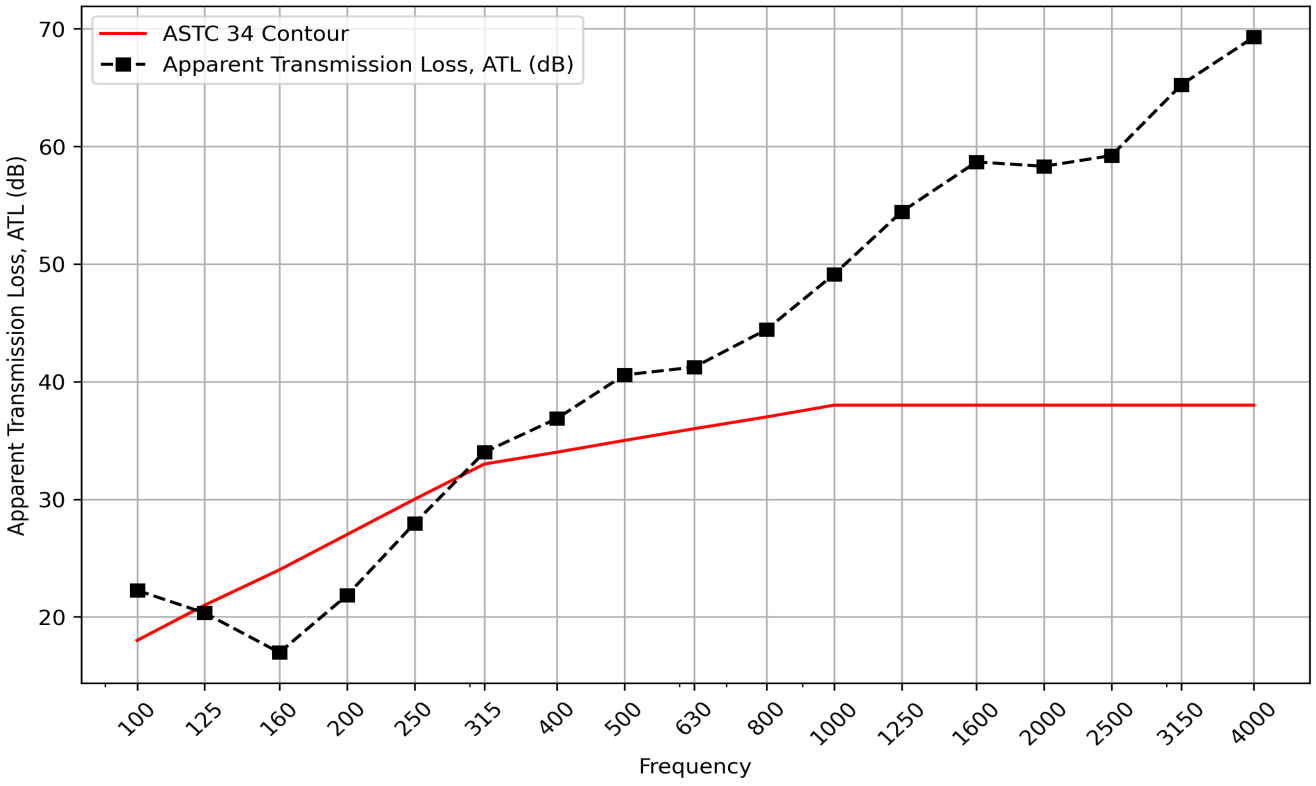
The Apparent Sound Transmission Class (ASTC) of 34 was calculated. The ASTC rating is based on Apparent Transmission Loss (ATL), and includes the effects of noise flanking. The ASTC reference contour is shown on the next page, and has been fit to the Apparent Transmission Loss values, in accordance with the procedure of ASTC Test Procedure ASTM E336-16

ASTC: 34
