Apparent Impact Insulation Class (AIIC)

DLAA Test No1.2.1Source Room:916Test SiteKaanapali ShoresReceiver Room:816

Client Kaanapali AOAO Test Assembly: Floor-ceiling

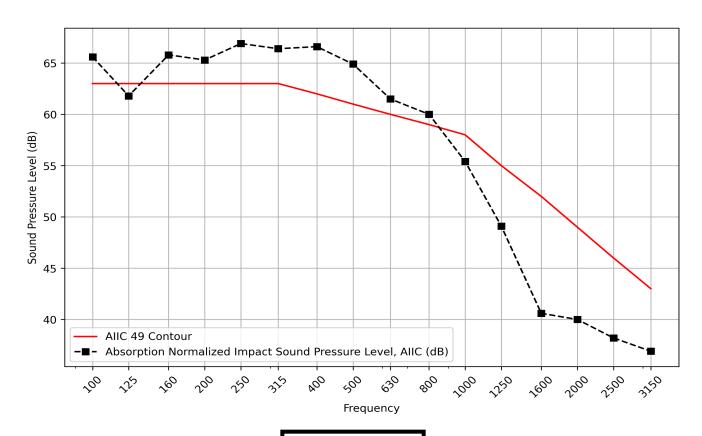
AIIC: 49

The Apparent Impact Insulation Class (AIIC) of 49 was calculated. The AIIC rating is based on Absorption Normalized Impact Sound Pressure Level (ANISPL), and includes the effects of noise flanking. The AIIC reference contour is shown on the next page, and has been fit to the Absorption Normalized Impact Sound Pressure Level values, in accordance with the procedure of ASTC Test Procedure ASTM E336-16 The results stated in this report represent only the specific construction and acoustical conditions present at the time of the test. Measurements performed in accordance with this test method on nominally identical constructions and acoustical conditions may produce different results.
