Noise Isolation Class (NIC)

DLAA Test No1.2.1Source Room:916Test SiteKaanapali ShoresReceiver Room:816

Client Kaanapali AOAO Test Assembly: Floor-ceiling

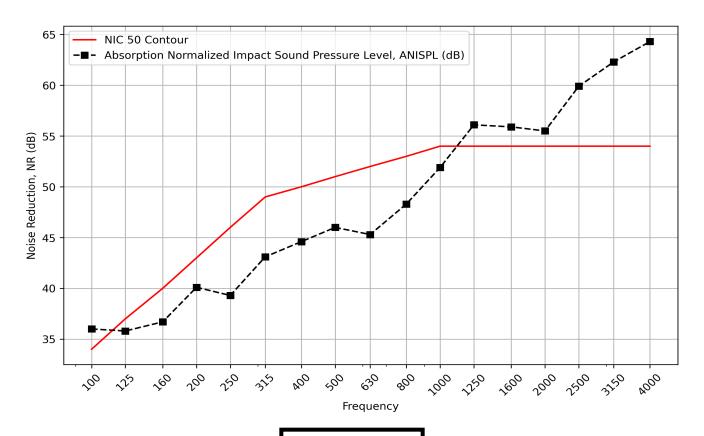
NIC: 50

The Noise Isolation Class (NIC) of 50 was calculated. The NIC rating is based on Noise Reduction (NR), and includes the effects of noise flanking. The NIC reference contour is shown on the next page, and has been fit to the Noise Reduction values, in accordance with the procedure of ASTC Test Procedure ASTM E336-16 The results stated in this report represent only the specific construction and acoustical conditions present at the time of the test. Measurements performed in accordance with this test method on nominally identical constructions and acoustical conditions may produce different results.
