## **Apparent Sound Transmission Class (ASTC)**

Report Date:
 4/9/25

DLAA Test No1.2.1Source Room:916Test SiteKaanapali ShoresReceiver Room:816

Client Kaanapali AOAO Test Assembly: Floor-ceiling

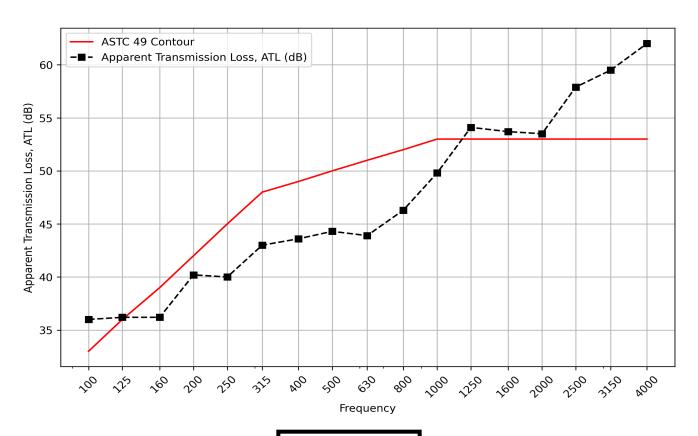
The Apparent Sound Transmission Class (ASTC) of 49 was calculated. The ASTC rating is based on Apparent Transmission Loss (ATL), and includes the effects of noise flanking. The ASTC reference contour is shown on the next page, and has been fit to the Apparent Transmission Loss values, in accordance with the procedure of ASTC Test Procedure ASTM E336-16
