Apparent Impact Insulation Class (AIIC)

Report Date: 2024-04-15 00:00:00 **Test Date:** 2024-04-04 00:00:00

DLAA Test No1.3.1Source Room:2nd Floor Bed 3Test SiteGentry aptsReceiver Room:1st Floor Bed 2ClientGentry BuildersTest Assembly:Floor-ceiling

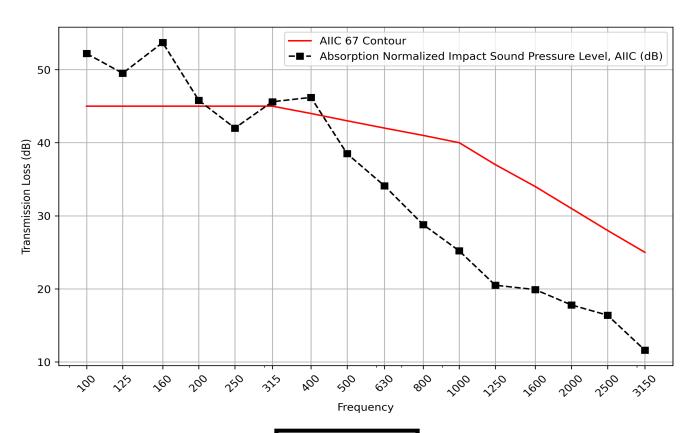
AIIC: 67

The Apparent Impact Insulation Class (AIIC) of 67 was calculated. The AIIC rating is based on Absorption Normalized Impact Sound Pressure Level (ANISPL), and includes the effects of noise flanking. The AIIC reference contour is shown on the next page, and has been fit to the Absorption Normalized Impact Sound Pressure Level values, in accordance with the procedure of ASTC Test Procedure ASTM E336-16 The results stated in this report represent only the specific construction and acoustical conditions present at the time of the test. Measurements performed in accordance with this test method on nominally identical constructions and acoustical conditions may produce different results.
