### **Apparent Impact Insulation Class (AIIC)**

DLAA Test No1.3.1Source Room:2nd Floor Bed 3Test SiteGentry aptsReceiver Room:1st Floor Bed 2ClientGentry BuildersTest Assembly:Floor-ceiling

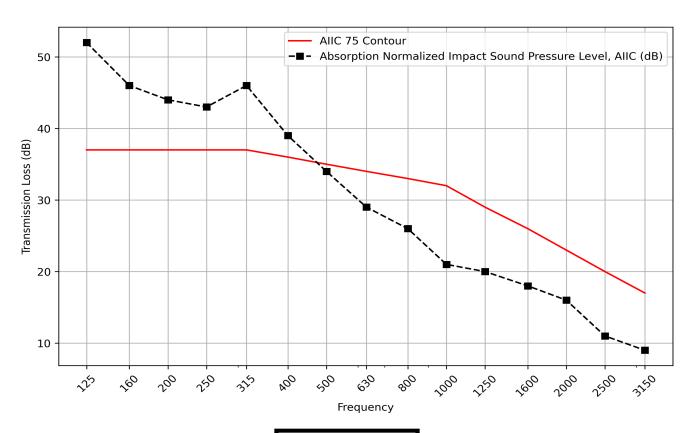
AIIC: 75

The Apparent Impact Insulation Class (AIIC) of 75 was calculated. The AIIC rating is based on Absorption Normalized Impact Sound Pressure Level (ANISPL), and includes the effects of noise flanking. The AIIC reference contour is shown on the next page, and has been "fit" to the Absorption Normalized Impact Sound Pressure Level values, in accordance with the procedure of ASTC Test Procedure ASTM E336-16 The results stated in this report represent only the specific construction and acoustical conditions present at the time of the test. Measurements performed in accordance with this test method on nominally identical constructions and acoustical conditions may produce different results.
