DLAA Test No
 1.4.1
 Source Room:
 2nd Floor Bed 1

Test Site
 Gentry apts
 Receiver Room:
 1st Floor Bed 1

Client
 Gentry Builders
 Test Assembly:
 Floor-ceiling

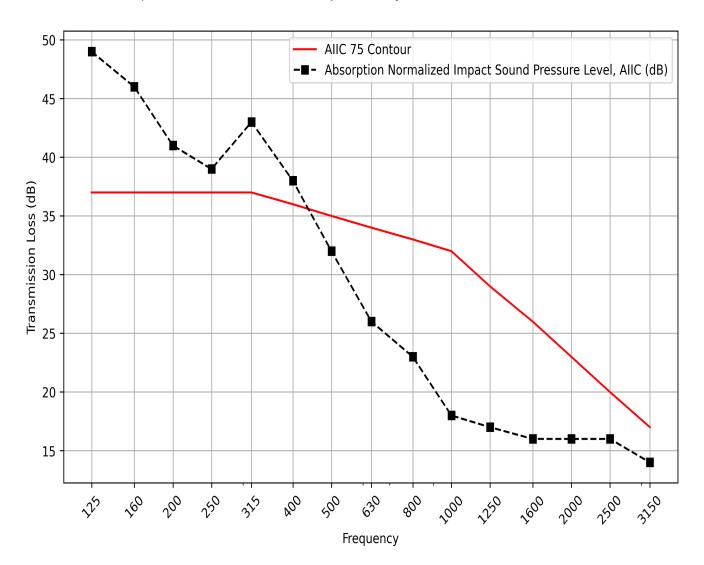
The Apparent Impact Insulation Class (AIIC) of 75 was calculated. The AIIC rating is based on Absorption Normalized Impact Sound Pressure Level (ANISPL), and includes the effects of noise flanking. The AIIC reference contour is shown on the next page, and has been "fit" to the Absorption Normalized Impact Sound Pressure Level values, in accordance with the procedure of ASTC Test Procedure ASTM E336-16 The results stated in this report represent only the specific construction and acoustical conditions present at the time of the test. Measurements performed in accordance with this test method on nominally identical constructions and acoustical conditions may produce different results.
