DLAA Test No
 1.3.1
 Source Room:
 2nd Floor Bed 3

Test Site
 Gentry apts
 Receiver Room:
 1st Floor Bed 2

Client
 Gentry Builders
 Test Assembly:
 Floor-ceiling

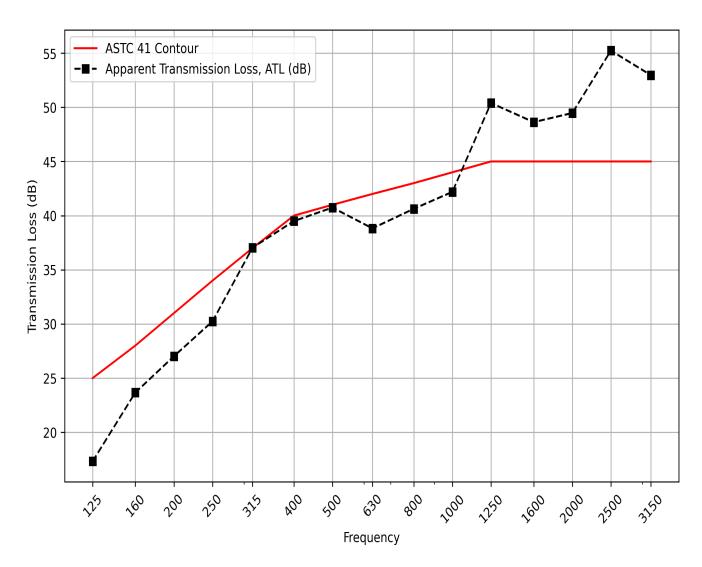
The Apparent Sound Transmission Class (ASTC) of 41 was calculated. The ASTC rating is based on Apparent Transmission Loss (ATL), and includes the effects of noise flanking. The ASTC reference contour is shown on the next page, and has been "fit" to the Apparent Transmission Loss values, in accordance with the procedure of ASTC Test Procedure ASTM E336-16
