Report Date: 2024-04-15 00:00:00 Source Room: 2nd Floor Kitchen

Test Date: 2024-04-04 00:00:00 **Receiver Room:** 1st Floor Great Room/Kitchen

DLAA Test No 1.2.1 Test Assembly: Floor-ceiling

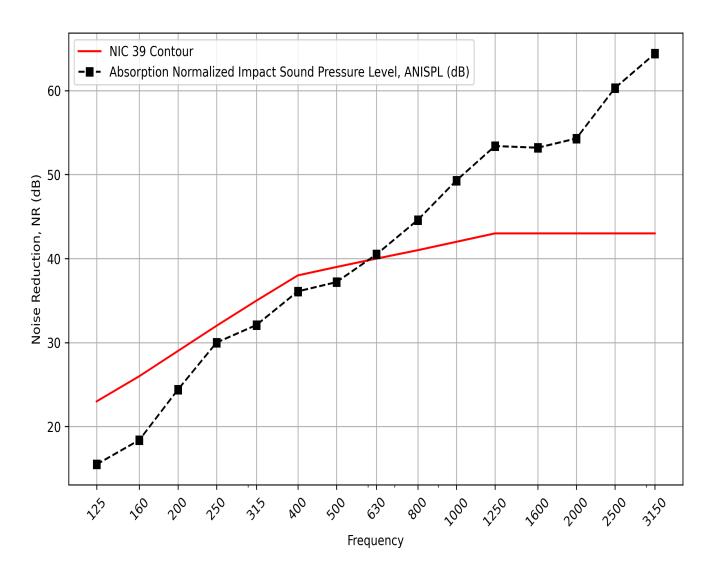
The Noise Isolation Class (NIC) of 39 was calculated. The NIC rating is based on Noise Reduction (NR), and includes the effects of noise flanking. The NIC reference contour is shown on the next page, and has been "fit" to the Noise Reduction values, in accordance with the procedure of ASTC Test Procedure ASTM E336-16. The results stated in this report represent only the specific construction and acoustical conditions present at the time of the test. Measurements performed in accordance with this test method on nominally identical constructions and acoustical conditions may produce different results.
