DLAA Test No
 1.4.1
 Source Room:
 2nd Floor Bed 1

Test Site
 Gentry apts
 Receiver Room:
 1st Floor Bed 1

Client
 Gentry Builders
 Test Assembly:
 Floor-ceiling

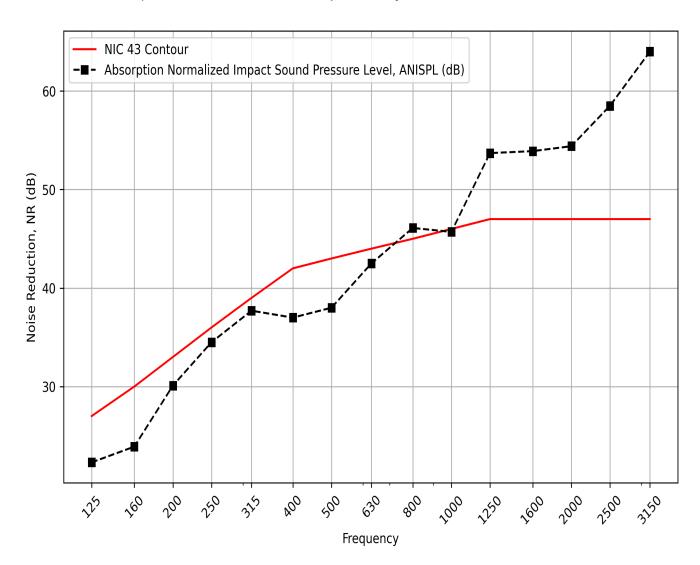
The Noise Isolation Class (NIC) of 43 was calculated. The NIC rating is based on Noise Reduction (NR), and includes the effects of noise flanking. The NIC reference contour is shown on the next page, and has been "fit" to the Noise Reduction values, in accordance with the procedure of ASTC Test Procedure ASTM E336-16. The results stated in this report represent only the specific construction and acoustical conditions present at the time of the test. Measurements performed in accordance with this test method on nominally identical constructions and acoustical conditions may produce different results.
