Report Date: 2024-04-15 00:00:00 **Test Date:** 2024-04-04 00:00:00

DLAA Test No
 1.3.1
 Source Room:
 2nd Floor Bed 3

Test Site
 Gentry apts
 Receiver Room:
 1st Floor Bed 2

Client
 Gentry Builders
 Test Assembly:
 Floor-ceiling

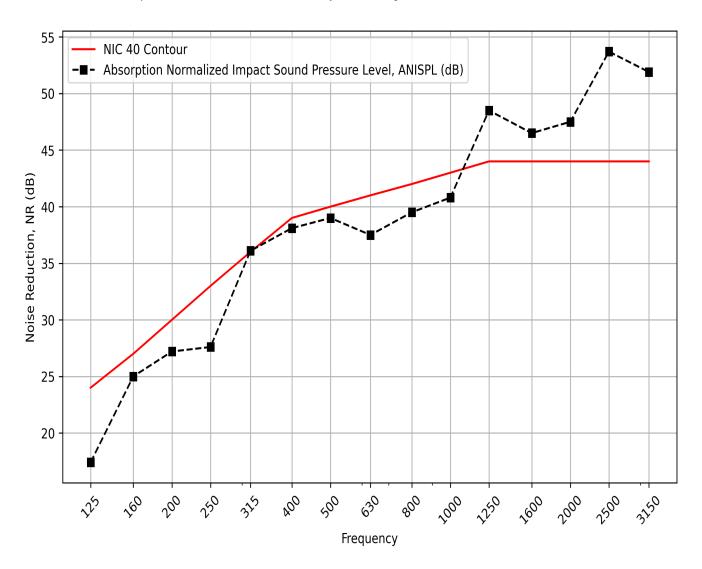
The Noise Isolation Class (NIC) of 40 was calculated. The NIC rating is based on Noise Reduction (NR), and includes the effects of noise flanking. The NIC reference contour is shown on the next page, and has been "fit" to the Noise Reduction values, in accordance with the procedure of ASTC Test Procedure ASTM E336-16. The results stated in this report represent only the specific construction and acoustical conditions present at the time of the test. Measurements performed in accordance with this test method on nominally identical constructions and acoustical conditions may produce different results.
