#### **Apparent Impact Insulation Class (AIIC)**

DLAA Test No1.1.1Source Room:513Test SiteKaanapali ShoresReceiver Room:413

Client Kaanapali AOAO Test Assembly: Floor-ceiling

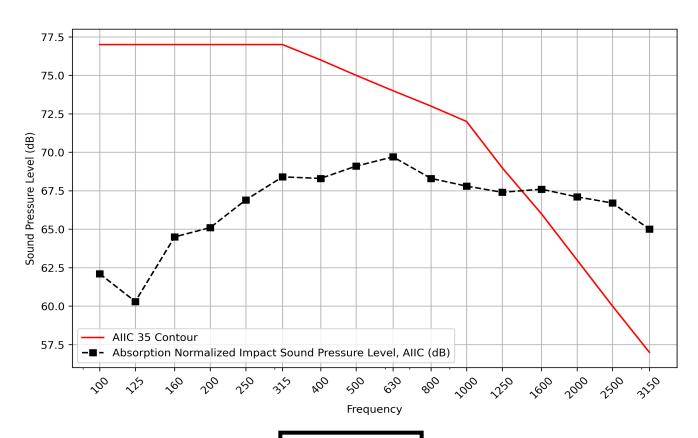
AIIC: 35

The Apparent Impact Insulation Class (AIIC) of 35 was calculated. The AIIC rating is based on Absorption Normalized Impact Sound Pressure Level (ANISPL), and includes the effects of noise flanking. The AIIC reference contour is shown on the next page, and has been fit to the Absorption Normalized Impact Sound Pressure Level values, in accordance with the procedure of ASTC Test Procedure ASTM E336-16 The results stated in this report represent only the specific construction and acoustical conditions present at the time of the test. Measurements performed in accordance with this test method on nominally identical constructions and acoustical conditions may produce different results.
