Report Date: 2024-04-15 00:00:00 Source Room: 2nd Floor Kitchen

DLAA Test No 1.2.1 **Test Assembly:** Floor-ceiling

STATEMENT OF TEST RESULTS:

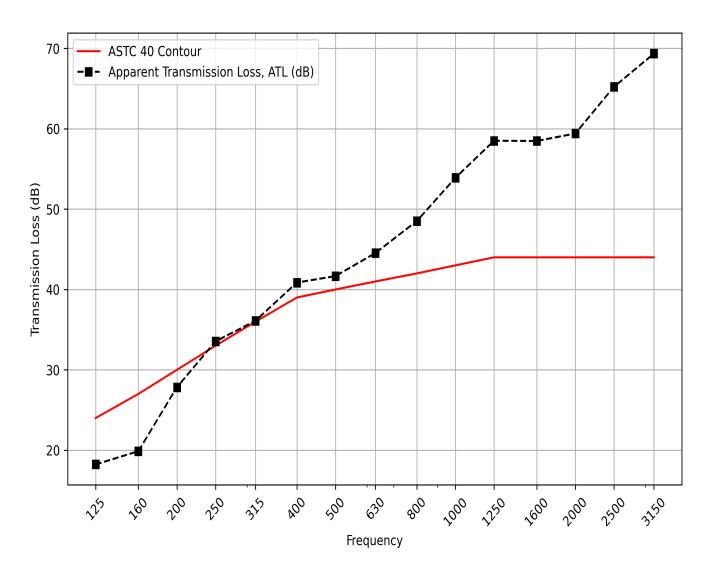
The Apparent Sound Transmission Class (ASTC) of 40 was calculated. The ASTC rating is based on Apparent Transmission Loss (ATL), and includes the effects of noise flanking. The ASTC reference contour is shown on the next page, and has been "fit" to the Apparent Transmission Loss values, in accordance with the procedure of ASTC Test Procedure ASTM E336-16
