2nd Floor Bed 1 **Report Date:** 2024-04-15 00:00:00 Source Room: Test Date: 2024-04-04 00:00:00 Receiver Room: 1st Floor Bed 1 DLAA Test No 1.4.1 Test Assembly: Floor-ceiling

Standard Test Method for Measurement of Airborne **ASTM E336-16** Sound Attenuation between Rooms in Buildings

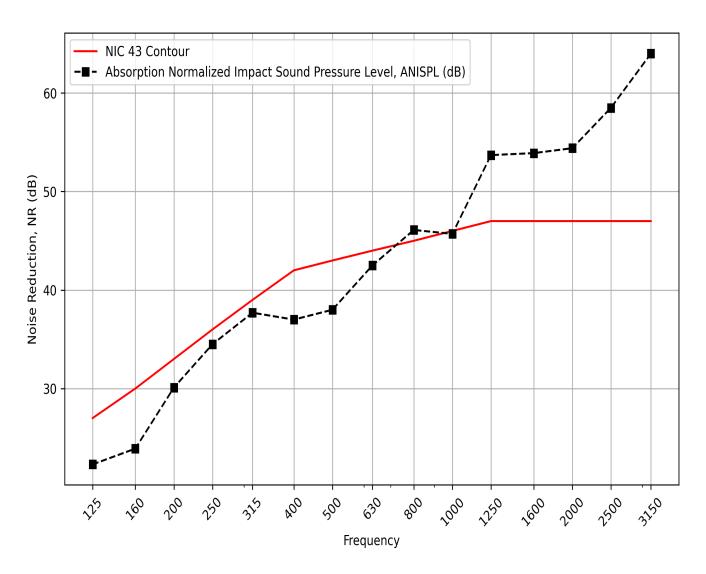
The Noise Isolation Class (NIC) of 43 was calculated. The NIC rating is based on Noise Reduction (NR), and includes the effects of noise flanking. The NIC reference contour is shown on the next page, and has been "fit" to the Noise Reduction values, in accordance with the procedure of ASTC Test Procedure ASTM E336-16. The results stated in this report represent only the specific construction and acoustical conditions present at the time of the test. Measurements performed in accordance with this test method on nominally identical constructions and acoustical conditions may produce different results.
